**Argyle Street Bridge  
Caledonia, Ontario**

**UNDERWATER INSPECTION**

**November, 2002**

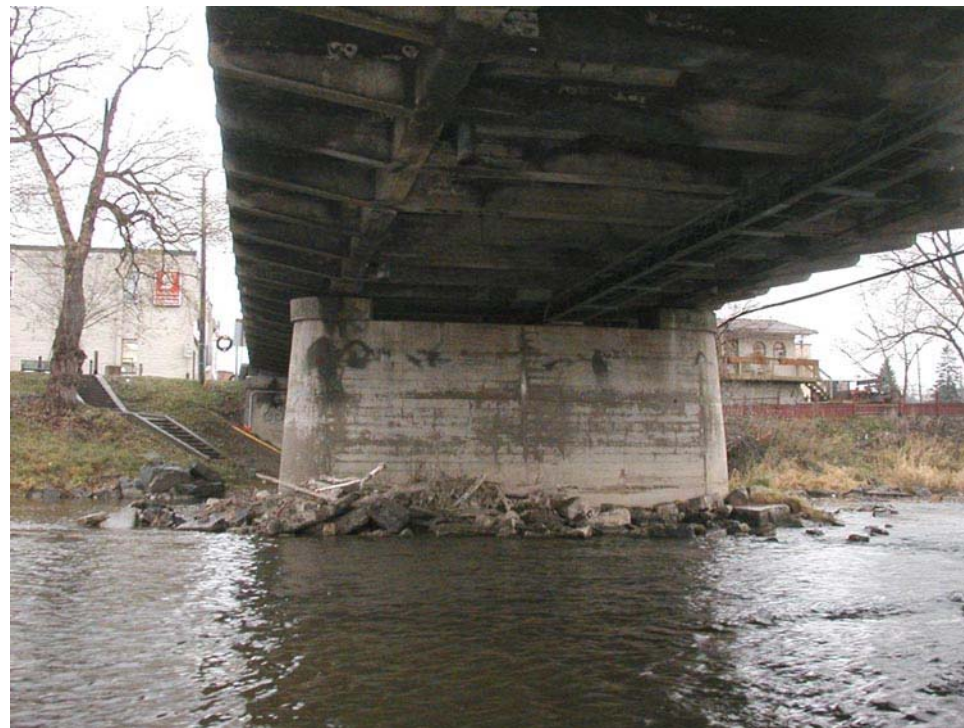
Pier No. 1, south face

The submerged portion of Pier No. 1 is encapsulated in rip-rap to above the water surface and not accessible for inspection. Above the rip-rap, the concrete appears to be in reasonably good condition and is probably indicative of the condition of the obscured portion of the pier.

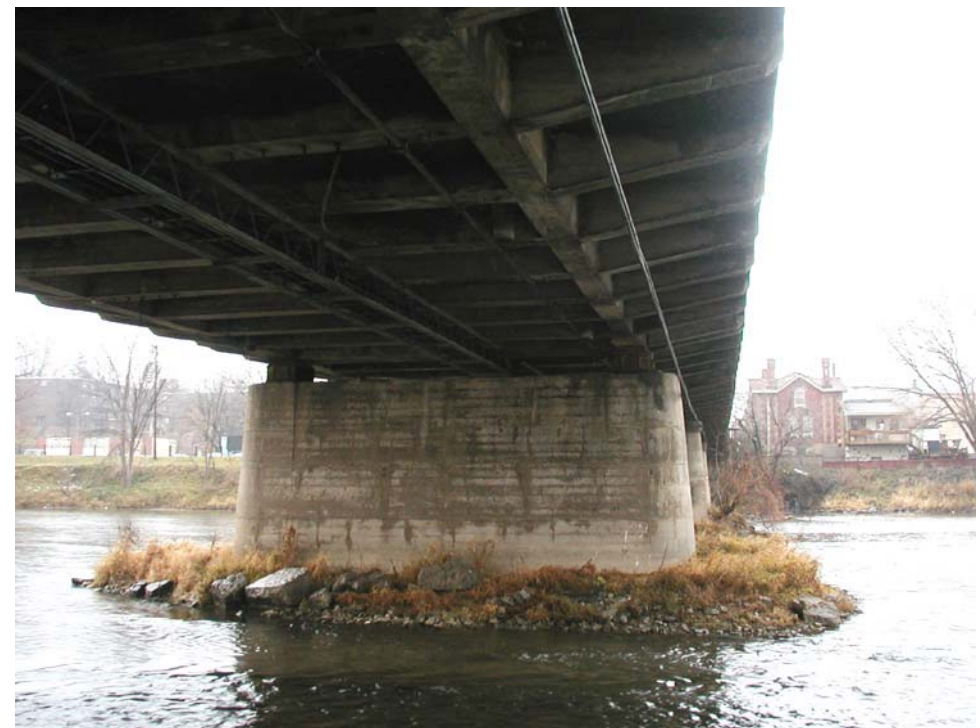
Pier No. 3, south face

The base of Piers No. 3 and 4 are both encapsulated in rip-rap to above the water surface.

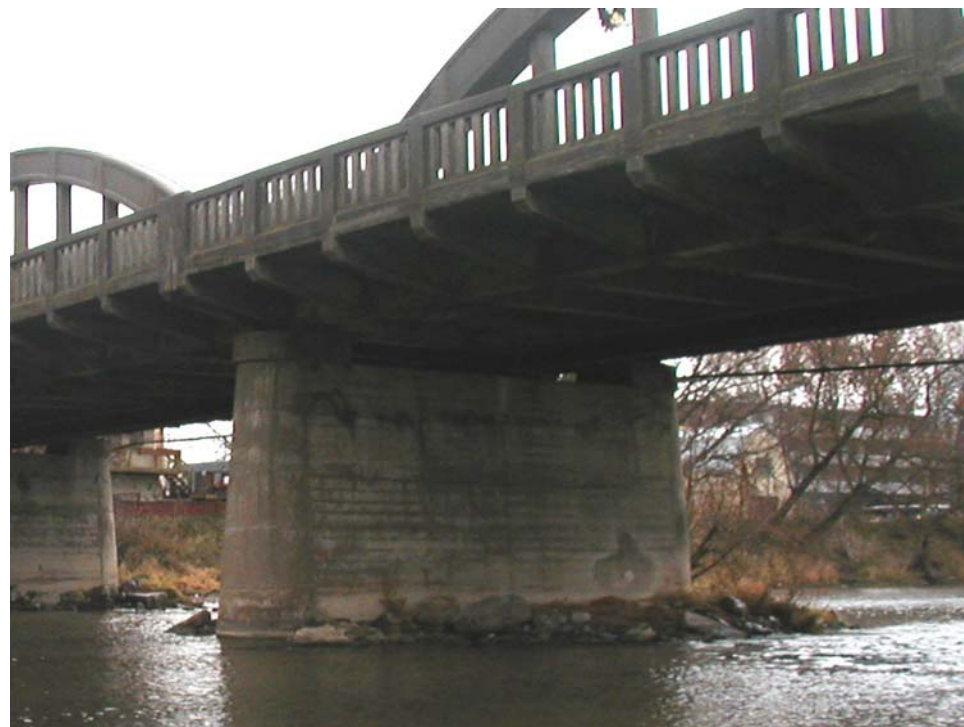
Pier No. 2, south face

The base of Pier No. 2 is protected with rip-rap to above the water surface except for a small portion at its upstream extremity where the rip-rap has probably been displaced. Here the base of the pier is exposed and appears to be in good condition as determined by a tactile examination.

The sounding survey did not identify any signs of significant erosion although at most piers the water depth immediately upstream, where stream bed erosion is anticipated, the water is slightly deeper. If the structure is to be retained that the rip-rap be replaced at the upstream end of the piers where it has been displaced.

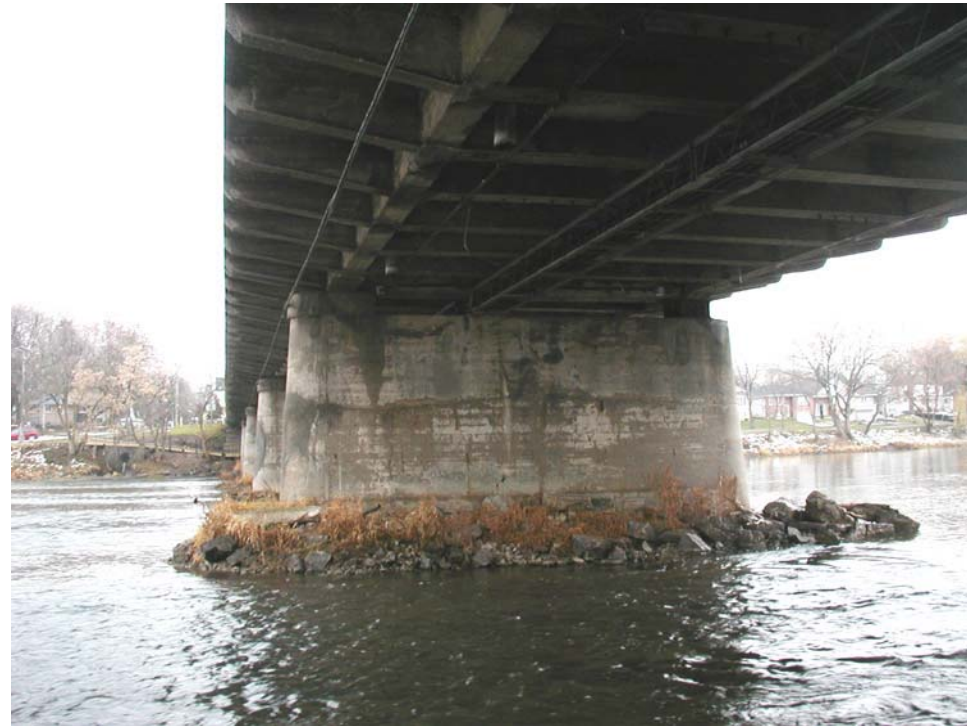
Pier No. 5, north face

The rip-rap around the base of Pier No. 5 extends to above the water surface except for a short section at the upstream face where the top of the base is exposed. A tactile examination of the concrete surfaces at this location did not reveal any deficiencies.

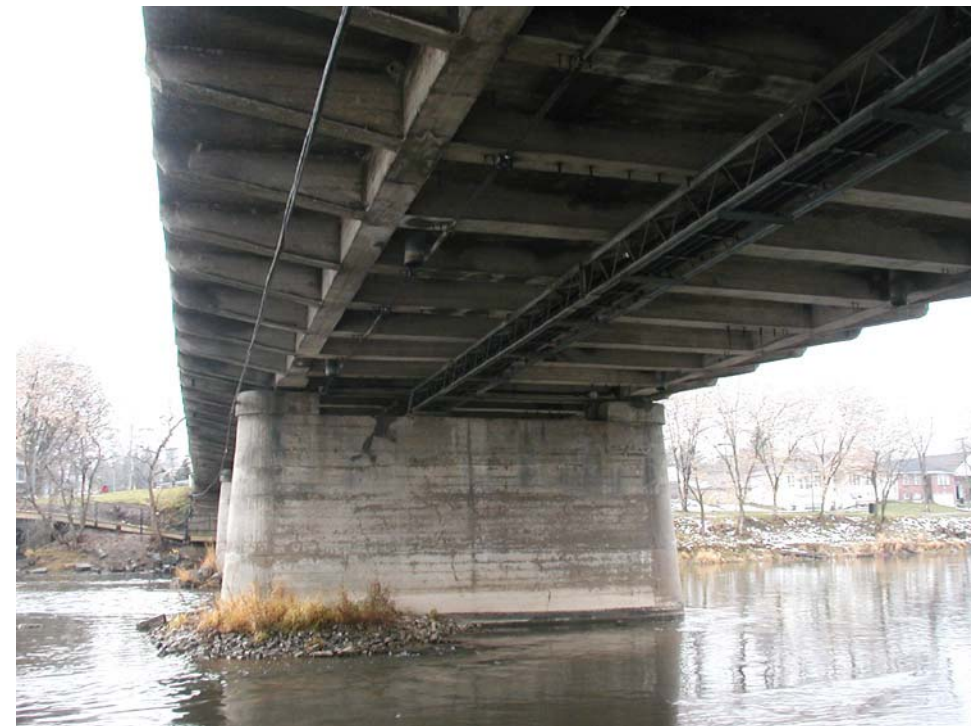
Pier No. 7, north face

The rip-rap around the base of Pier No. 7 extends to above the water surface over about two thirds of the downstream portion. Upstream of this, it gradually drops away to expose the gravel

river bottom at the upstream face. A tactile examination of the exposed concrete surfaces in this area did not reveal any deficiencies.

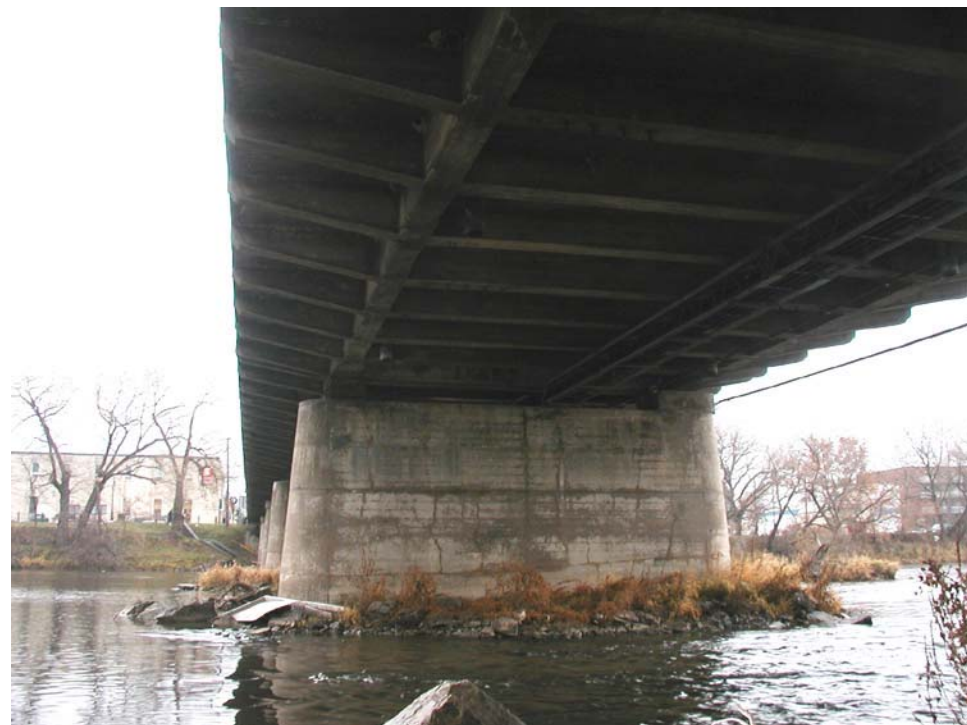
Pier No. 6, south face

The base of Pier No. 6 is encapsulated in rip-rap to above the water surface.

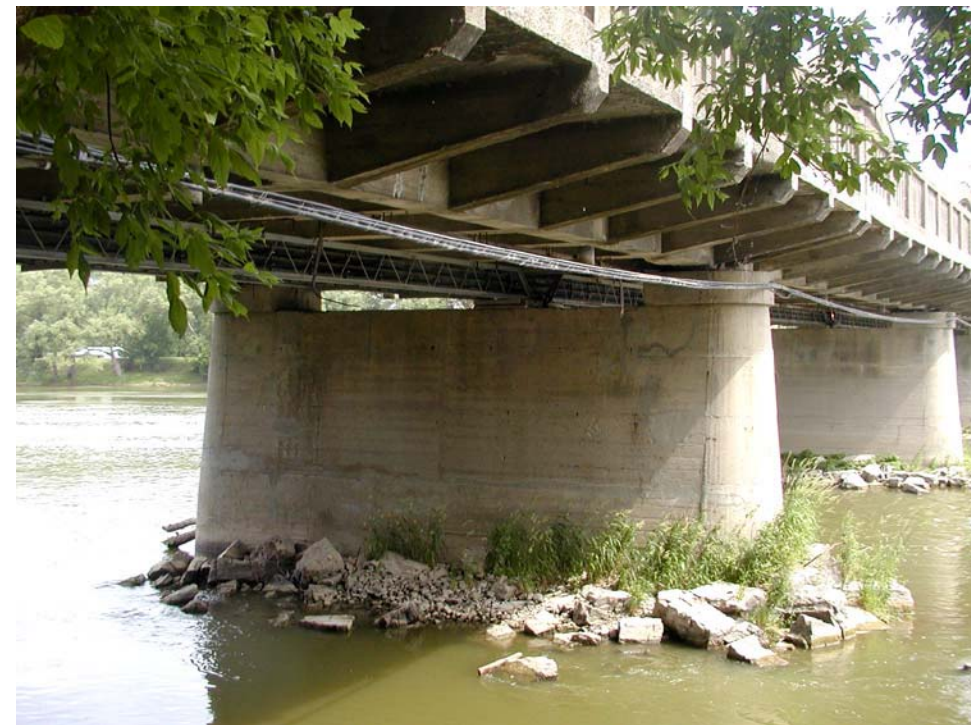
Pier No. 8, south face

The rip-rap around Pier No. 8 extends to above the water surface generally throughout. The exception is at the upstream face where it drops abruptly to the gravel bottom. A tactile examination of the exposed concrete in this location did not reveal any deficiencies.
