View of Argyle Street Bridge over Grand River.

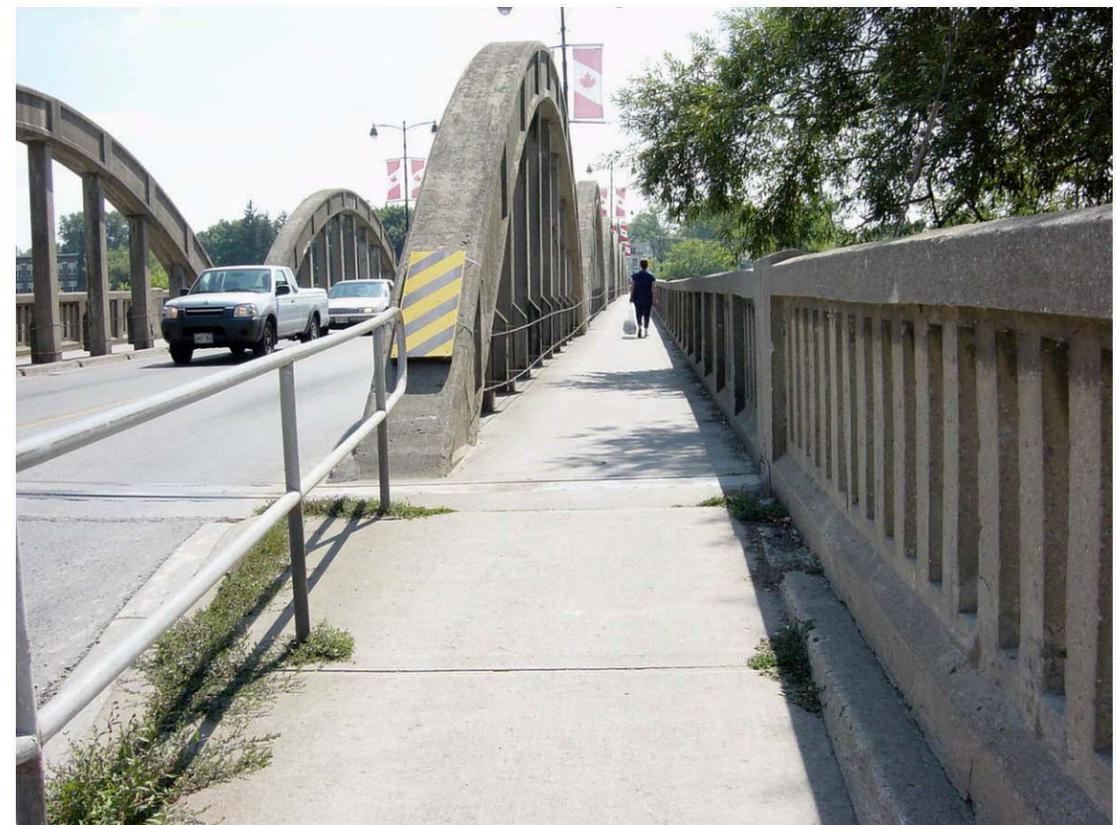
General view of sidewalk, railing, expansion joint, and concrete arches.

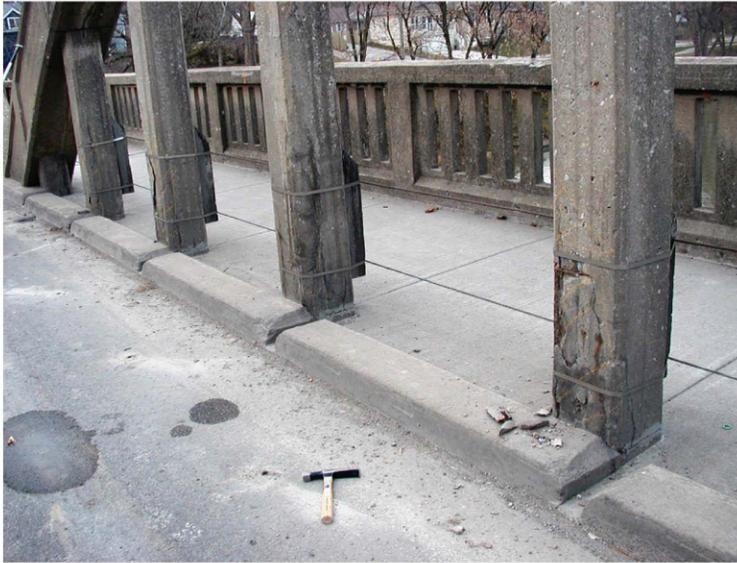
Concrete arch hanger is in poor condition.

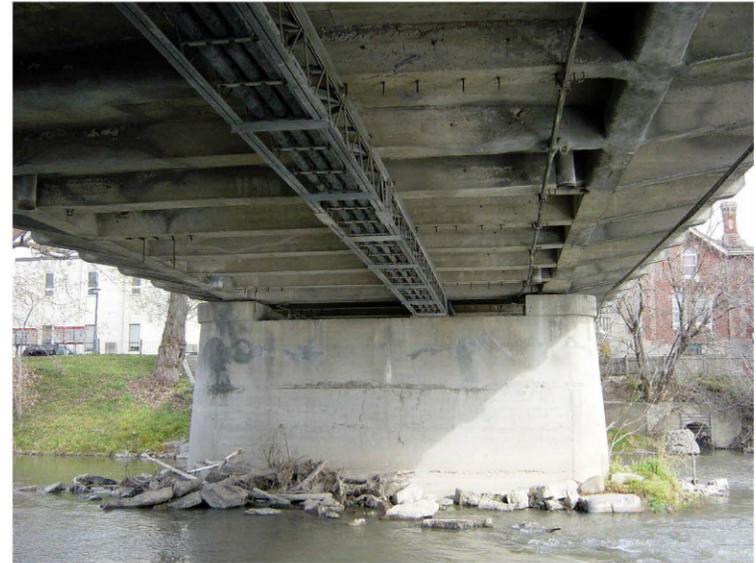
Underside of deck is in poor condition with numerous areas of sprayed concrete repairs on the underside of the deck. Utilities are mounted on the soffit. This is a typical pier profile with boulder/rock rip rap.

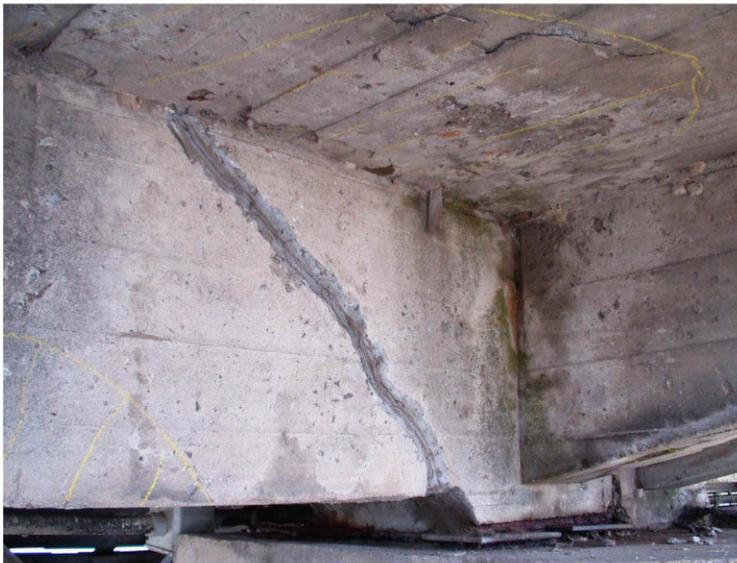
Concrete arch beam is in poor condition. Typical diagonal crack at end of main arch beam is clearly visible.

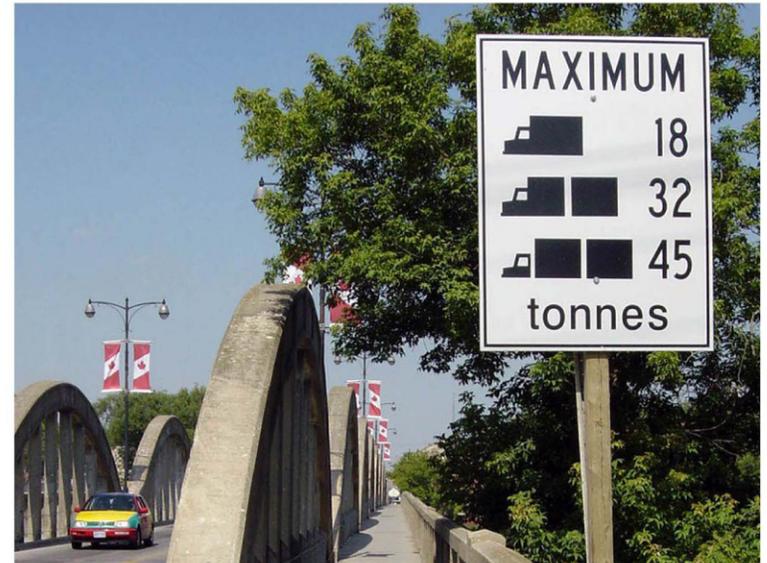
View of load posting sign at the south approach.

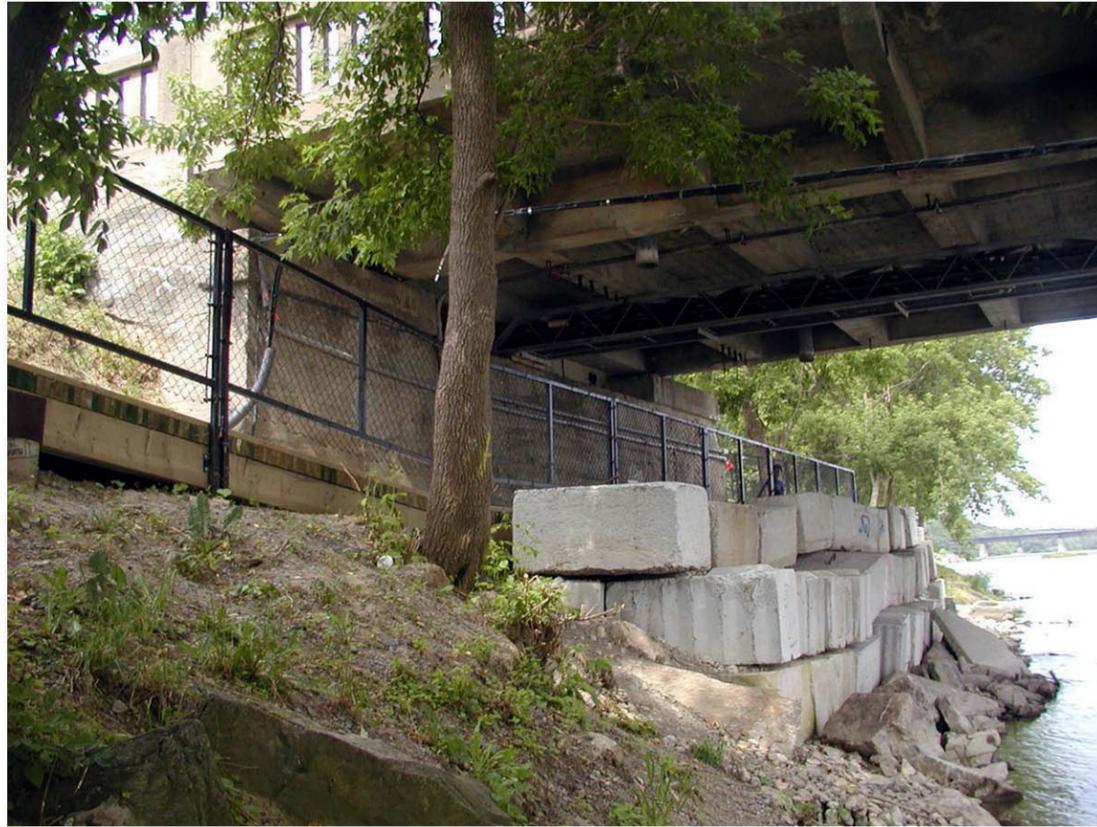
Concrete blocks and walkway at south abutment.

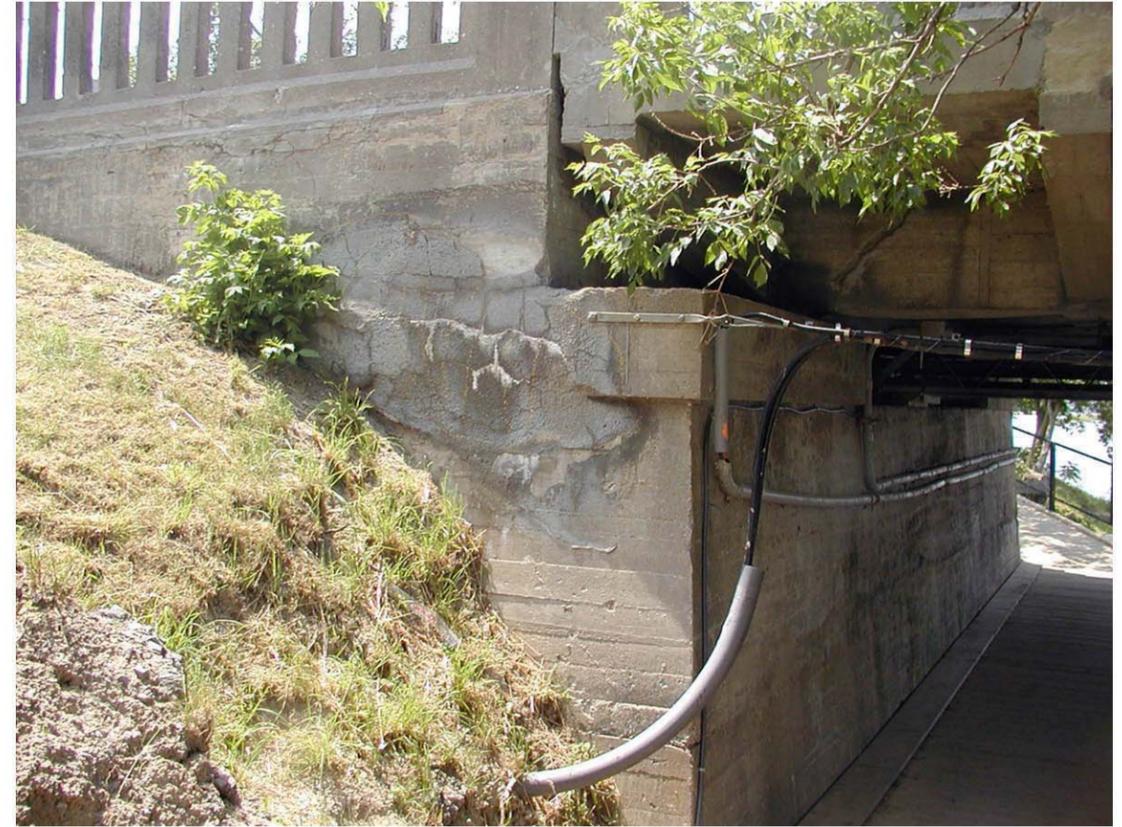
Southeast wingwall in fair condition, typical for all wingwalls.
