DETAILED BRIDGE DECK
CONDITION SURVEY

Argyle Street South Bridge
Old Highway 6 over the Grand River
Caledonia, Haldimand County

Site #9-002

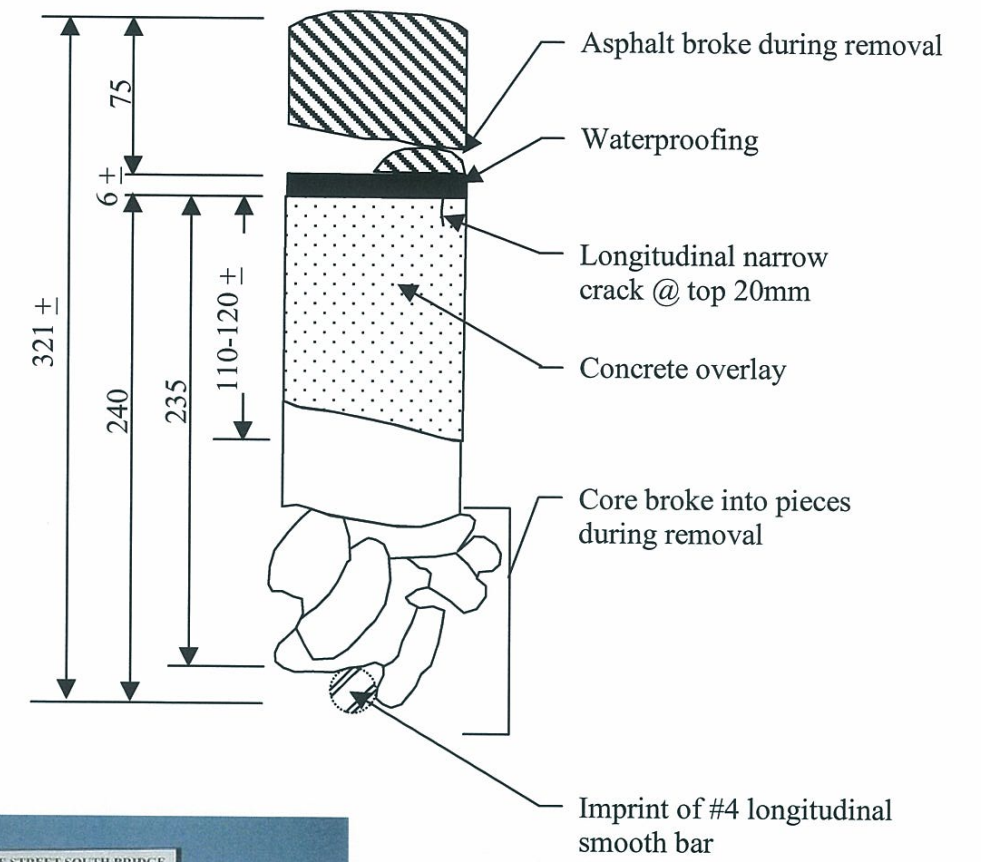
All cores and sawn asphalt samples showed no significant defects on the top concrete overlay layer, except for a narrow longitudinal crack at the top 20mm of the overlay in Core C-14 and a narrow transverse crack at the bottom 110mm in Core C-9. No significant deterioration of the original concrete deck below the overlay layer in any of the core samples.

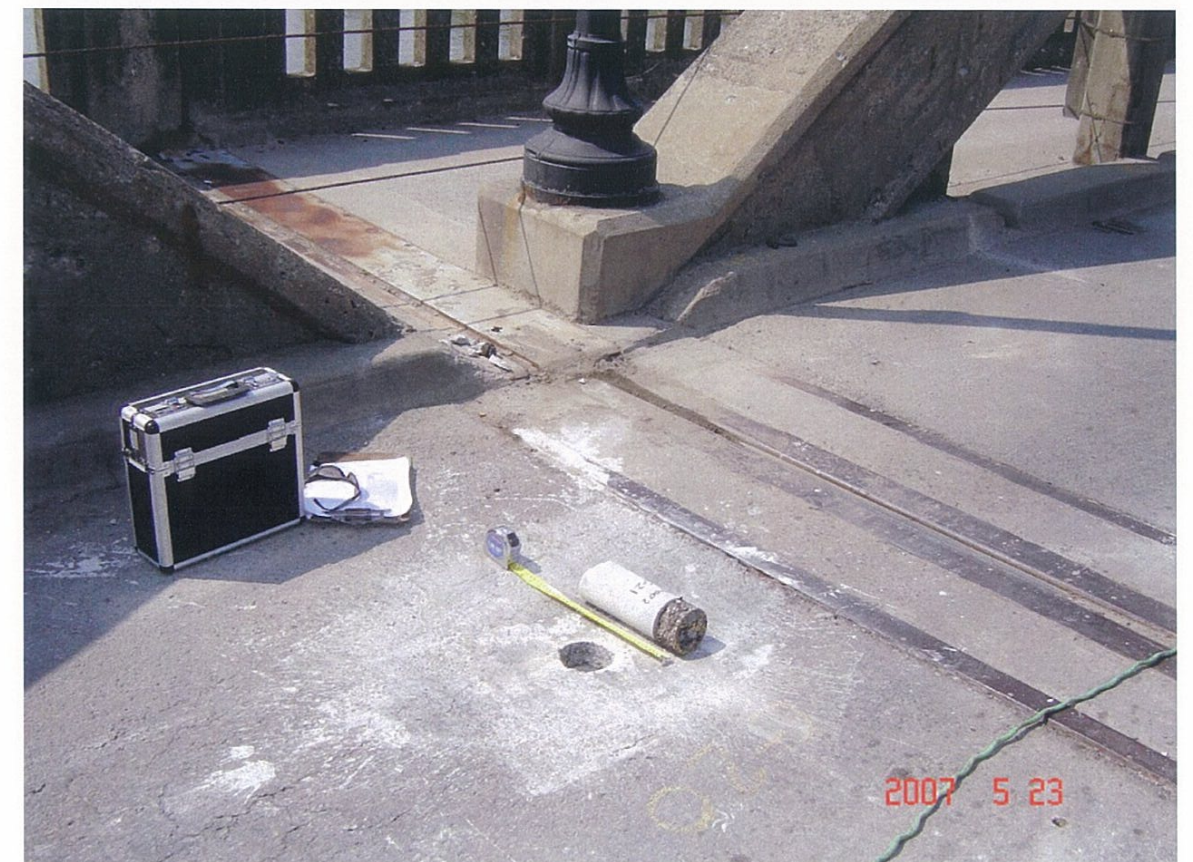
06 Light depression with cracks at NW corner of Span 8

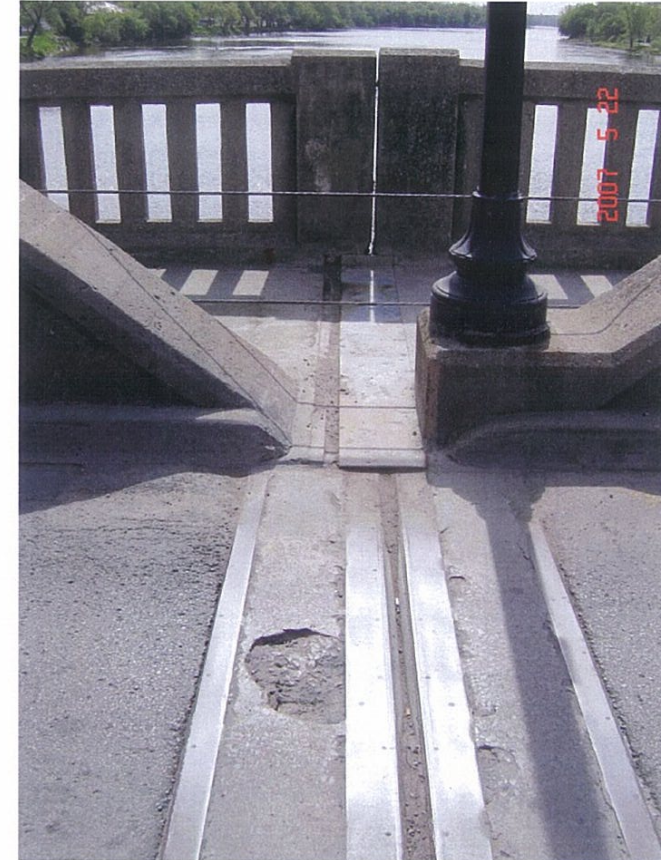
09 Local spalled on concrete end-dam (TYP)

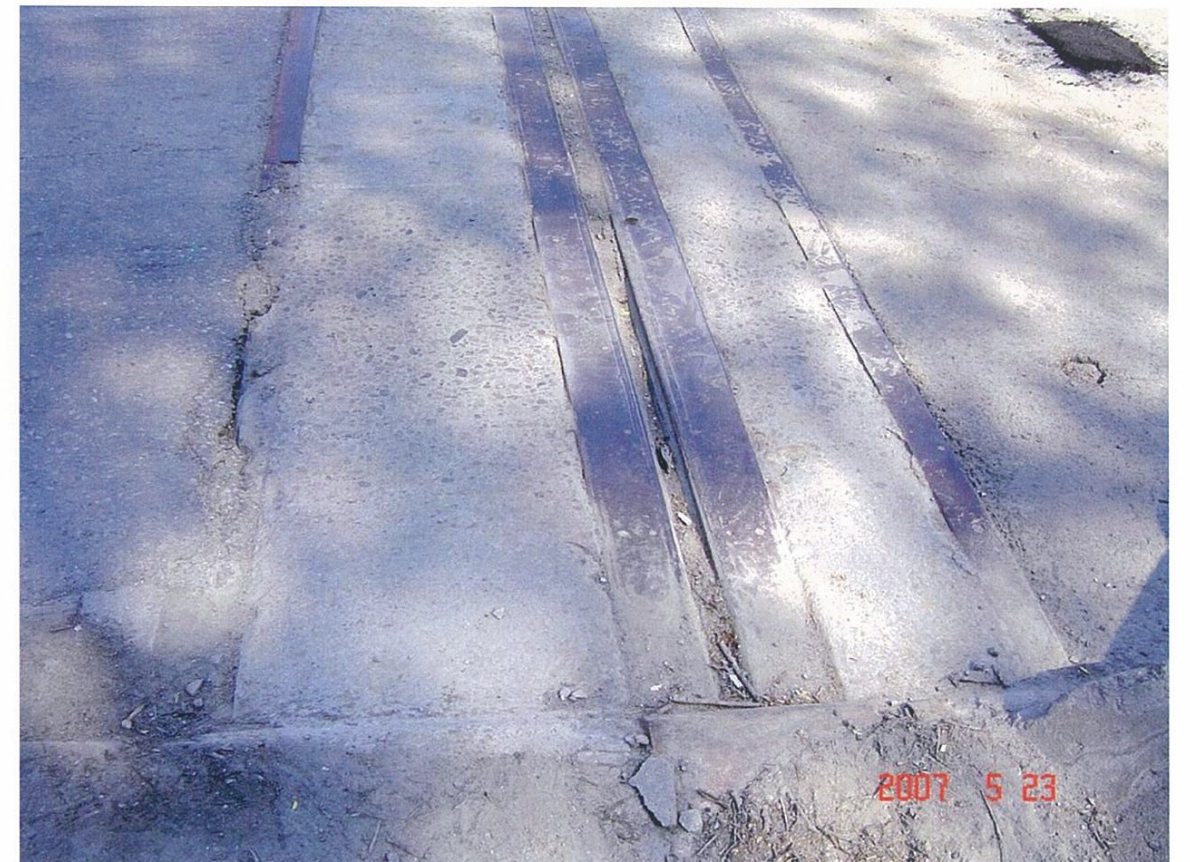
10 Missing section of armouring steel angle @ North Abutment Joint

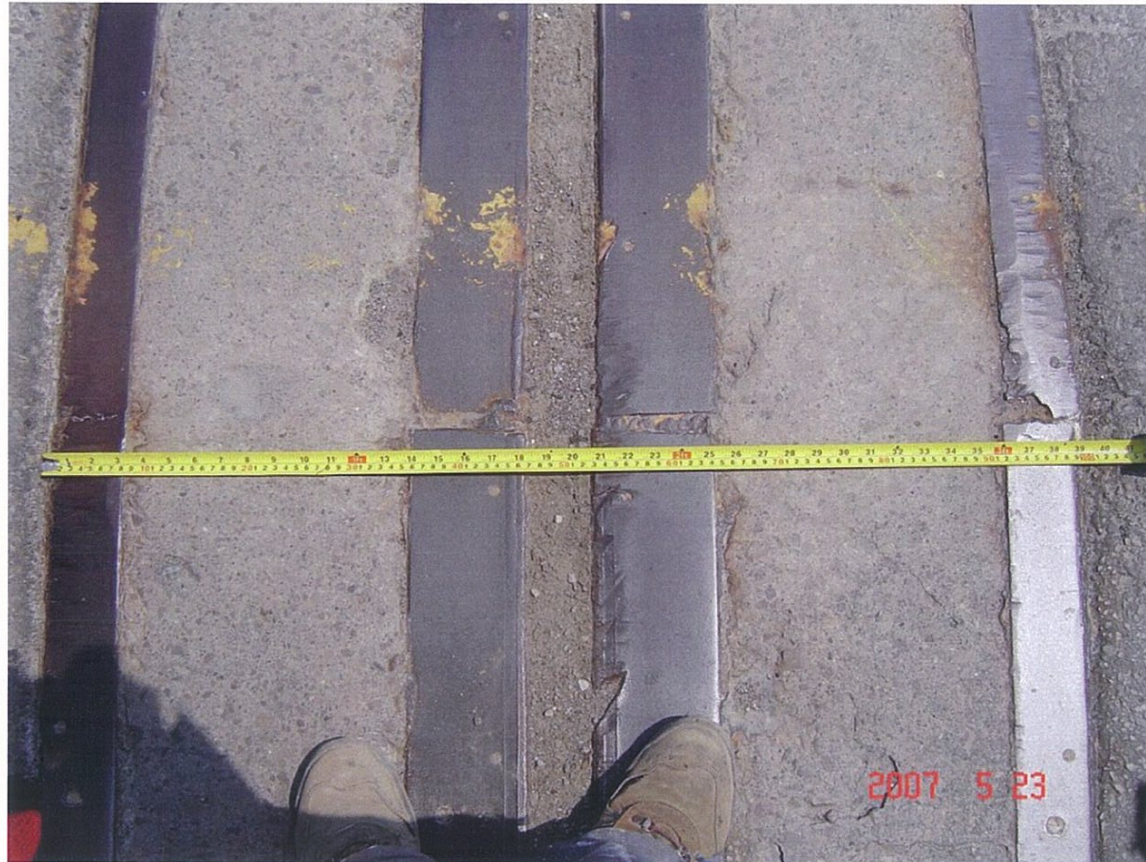
All expansion joints at the north and south ends of the deck and at the piers are of a strip seal type. All deck joints including seals, concrete end-dams, top of ballast walls, and steel armouring angles were completely replaced during the 1983 rehabilitation of the bridge structure. All joint seals were typically filled with sand/gravel and roadway debris (Photos 7 and 8). Where inspected, the seals were found to be in good condition. All concrete dams typically exhibit small pockets of shallow spalls along the length of the joint steel angles. Isolated large shallow spalled areas present on concrete dams at the location Piers 2 to 4, and at Pier 8 (Photo 9). A 1.7m section of steel nosing angle at top corner of the concrete ballast wall at the northwest corner appeared to have been torn off by a plow (Photo 10). Damaged from plows was also noted on the joint steel angle at Pier 2 near the centerline of the road (Photo 11).

11 Damaged expansion joint armouring steel @ Pier 2 (TYP)

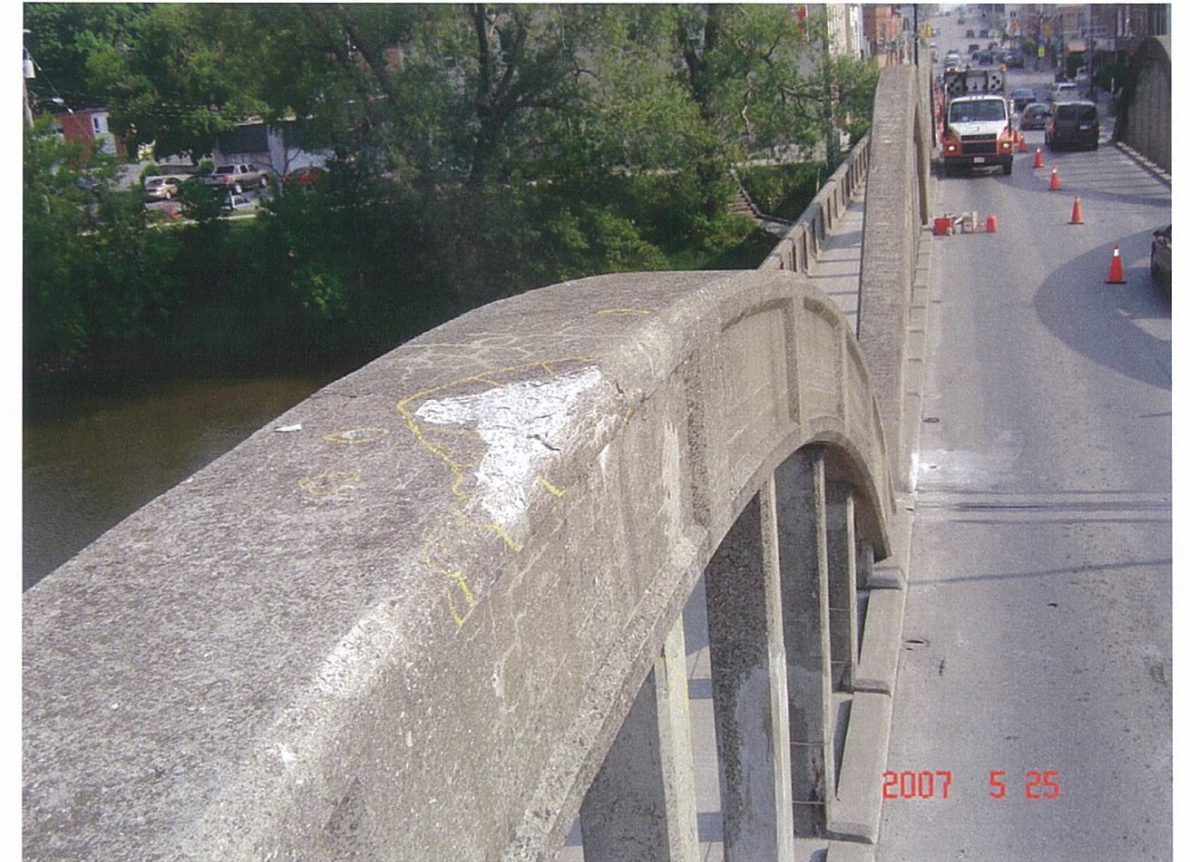
13 Minor delamination & spalled at top of W arch, Span 3

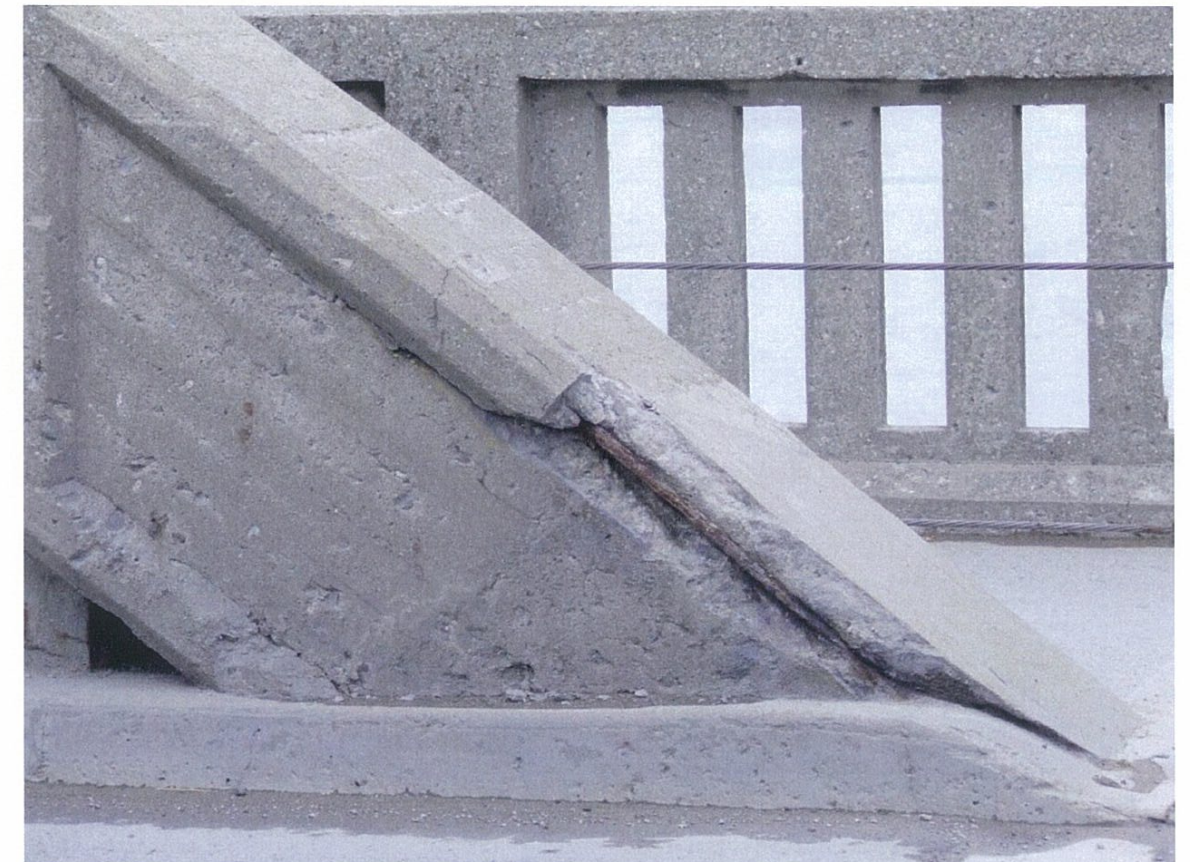
14 Cracked & Spalled south end of east arch @ Span 7

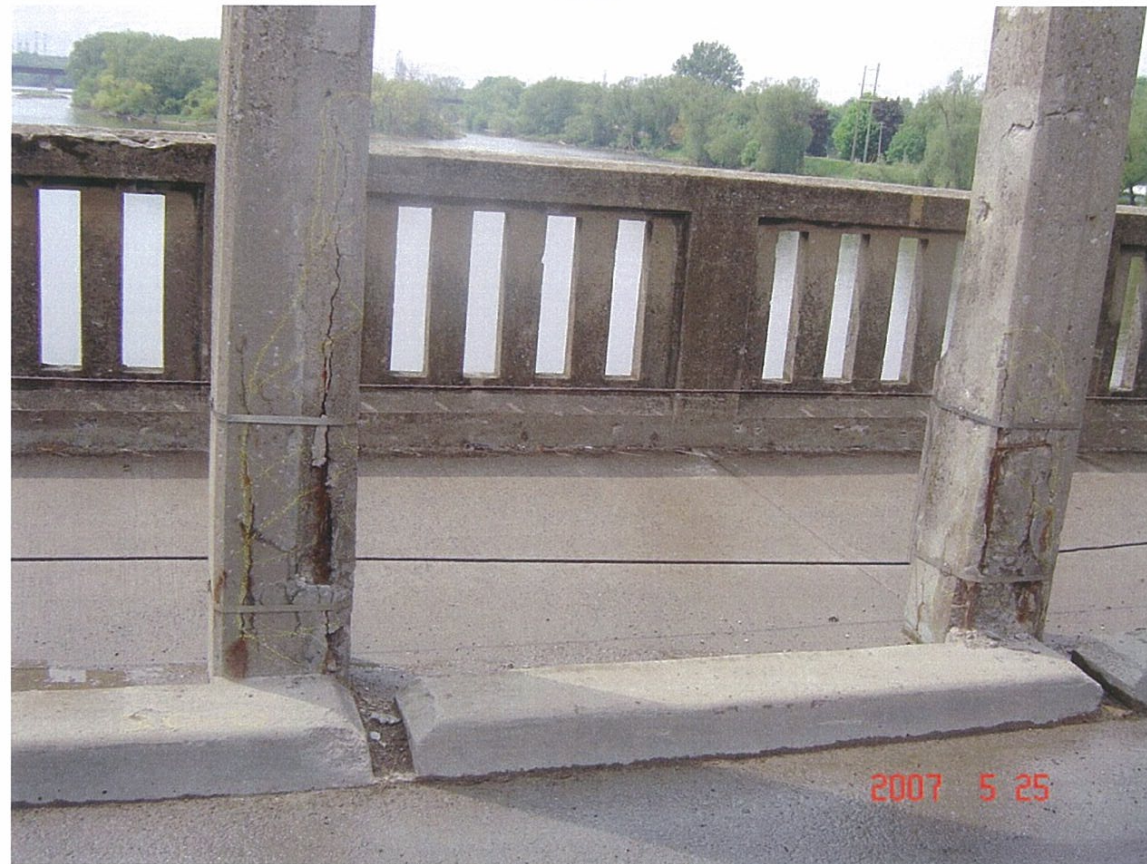
15 Typical cracks, delamination and spalls on arch hangers

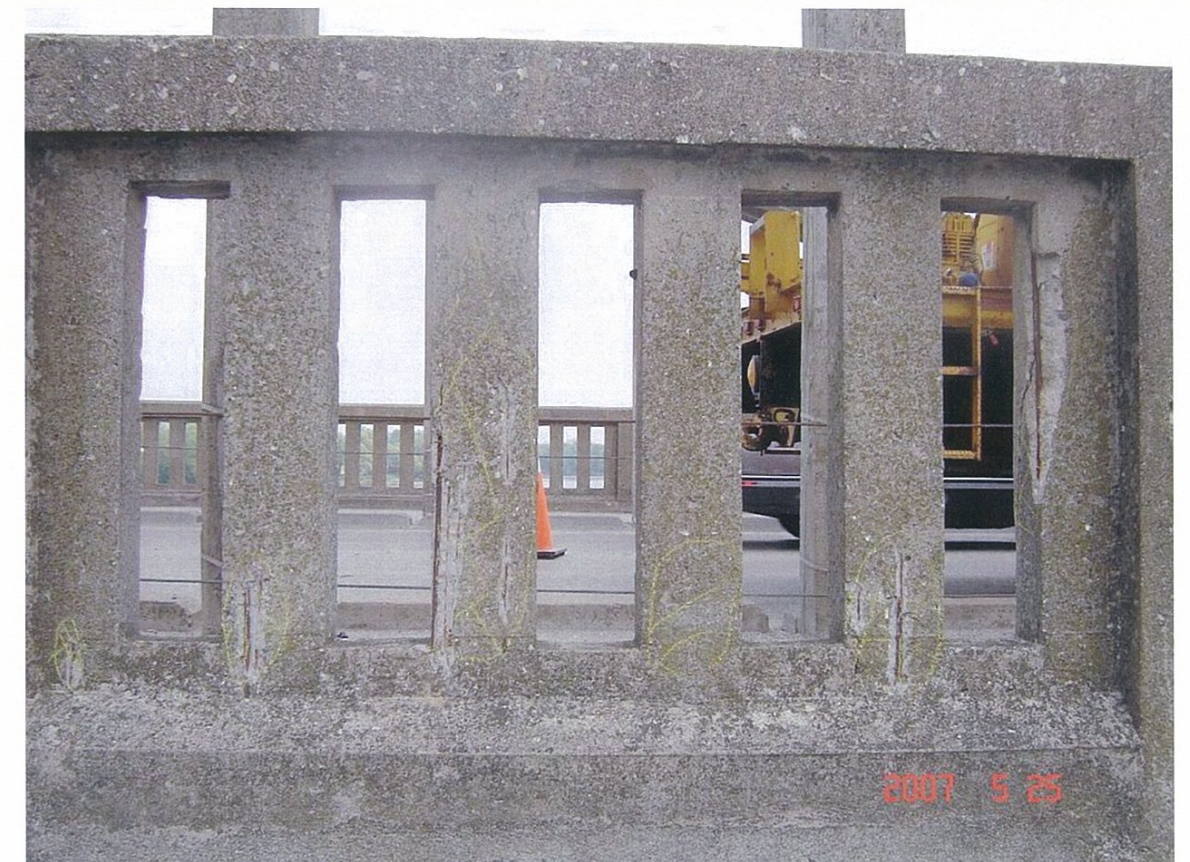
The east and west concrete railings, over the bridge length, are generally in fair to good condition with localized small delamination and spalled areas (Photo 18). A medium to wide horizontal crack was found running continuously over two rail panels, across the top of the ballasters and posts, presents at the south end of the east

18 Delamination & Spalls on outside face of W Rail (TYP), Span 5

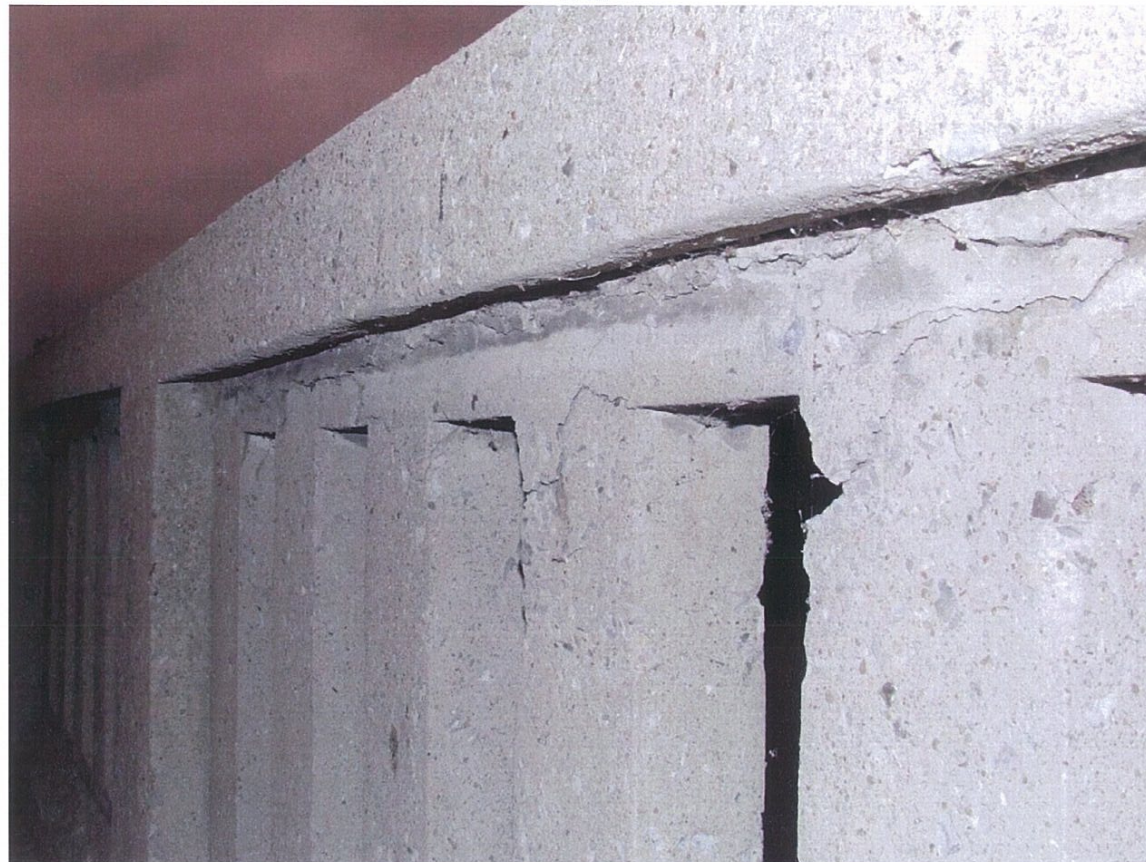
rail at Span 5 (Photo 19). The north approach end panel of the west rail was also found cracked along the bottom of the rail panel. Refer to Drawings 9-002-05 and 06 in Appendix “H” for observations of the railings.

19 Lengthy horizontal crack on E rail, Span 5

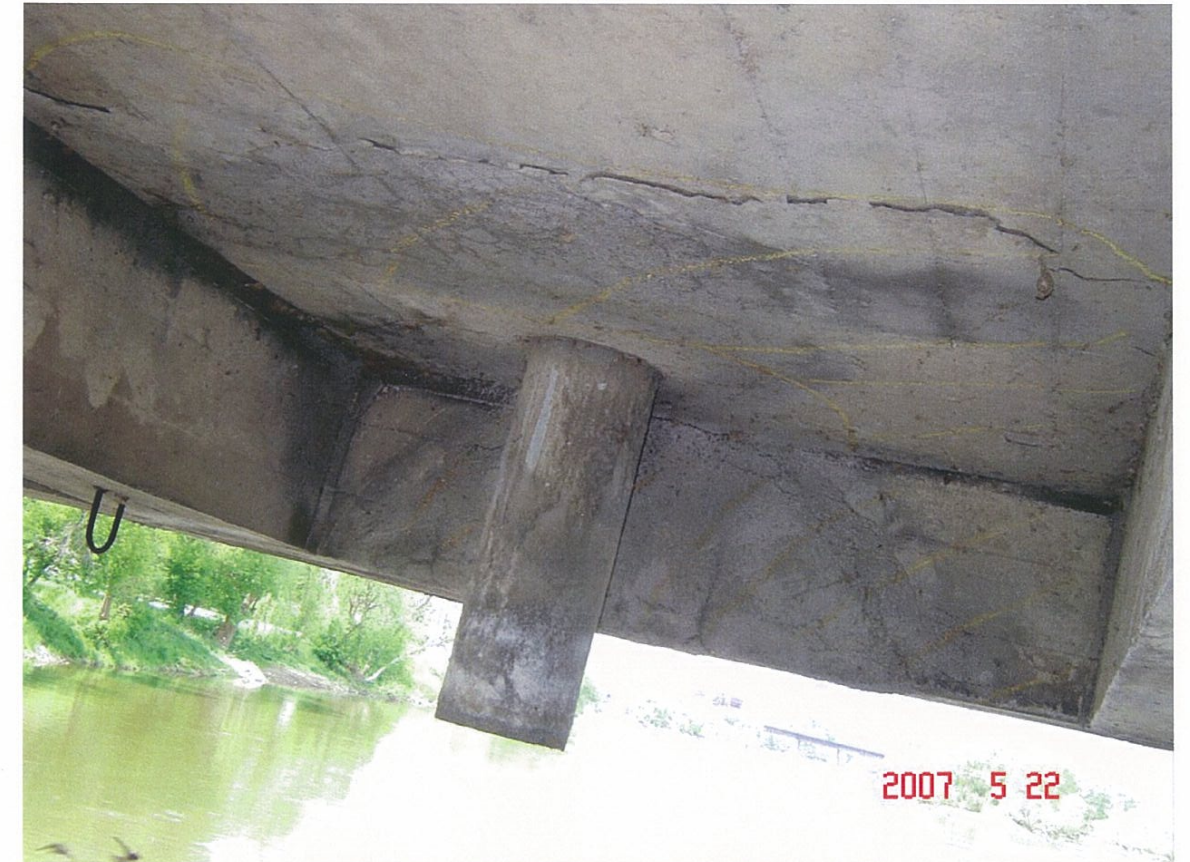
25 Typical delamination and patched areas on soffit at deck drain

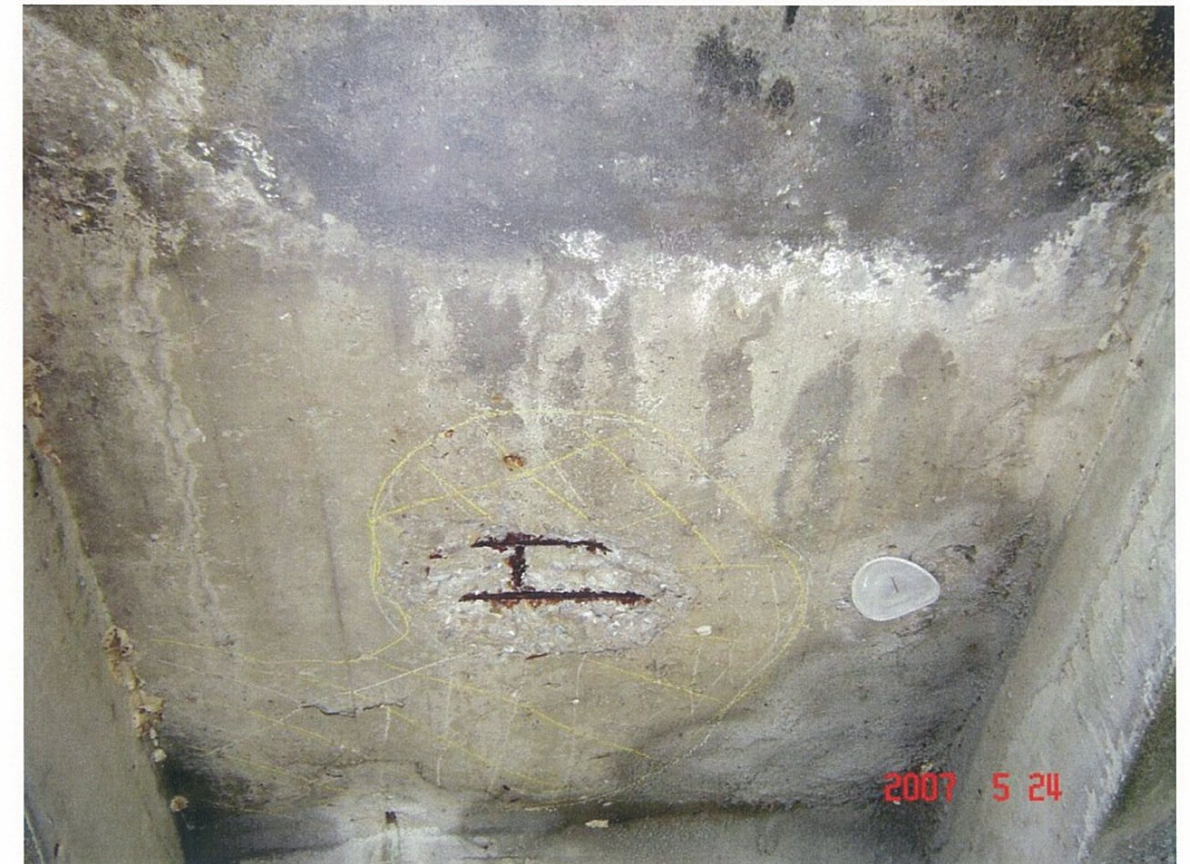
26 Typical spalled pocket on soffit

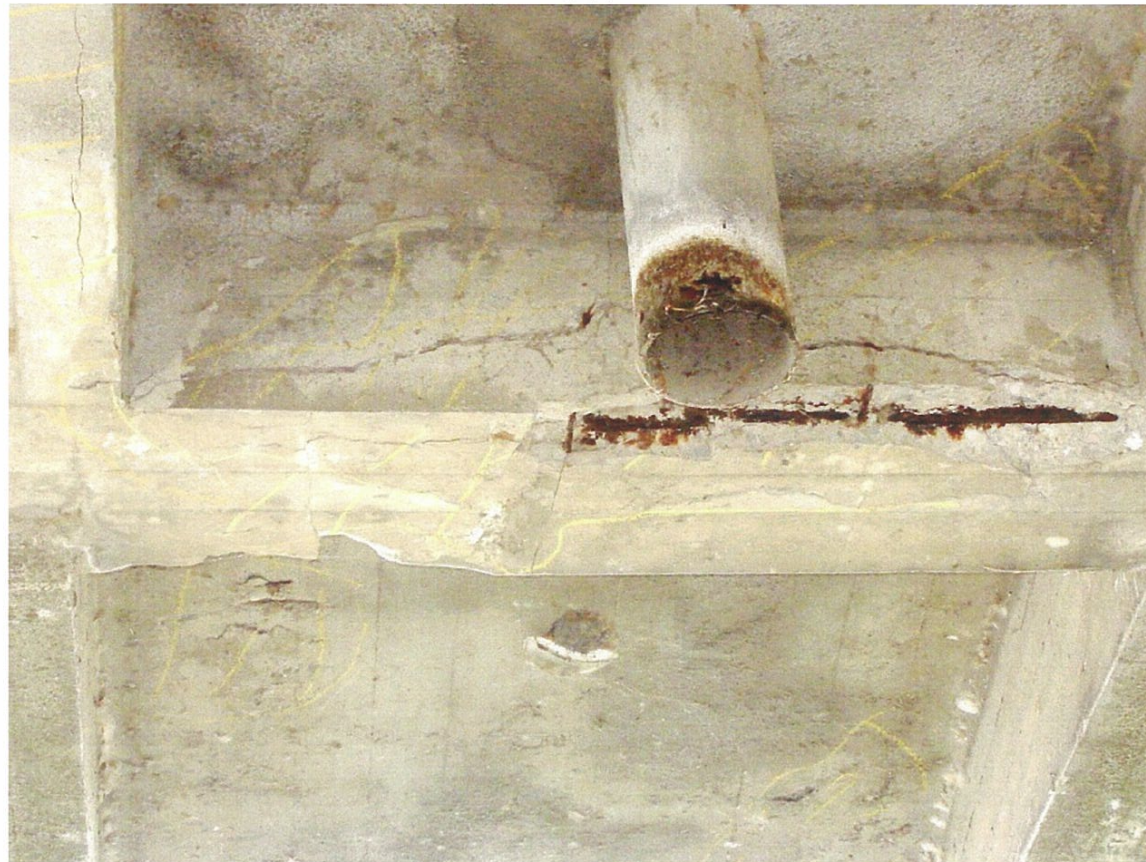
27 Cracked, Delamination and Spalled on bottom chord adjacent to a drain pipe in Span 4 (TYP)

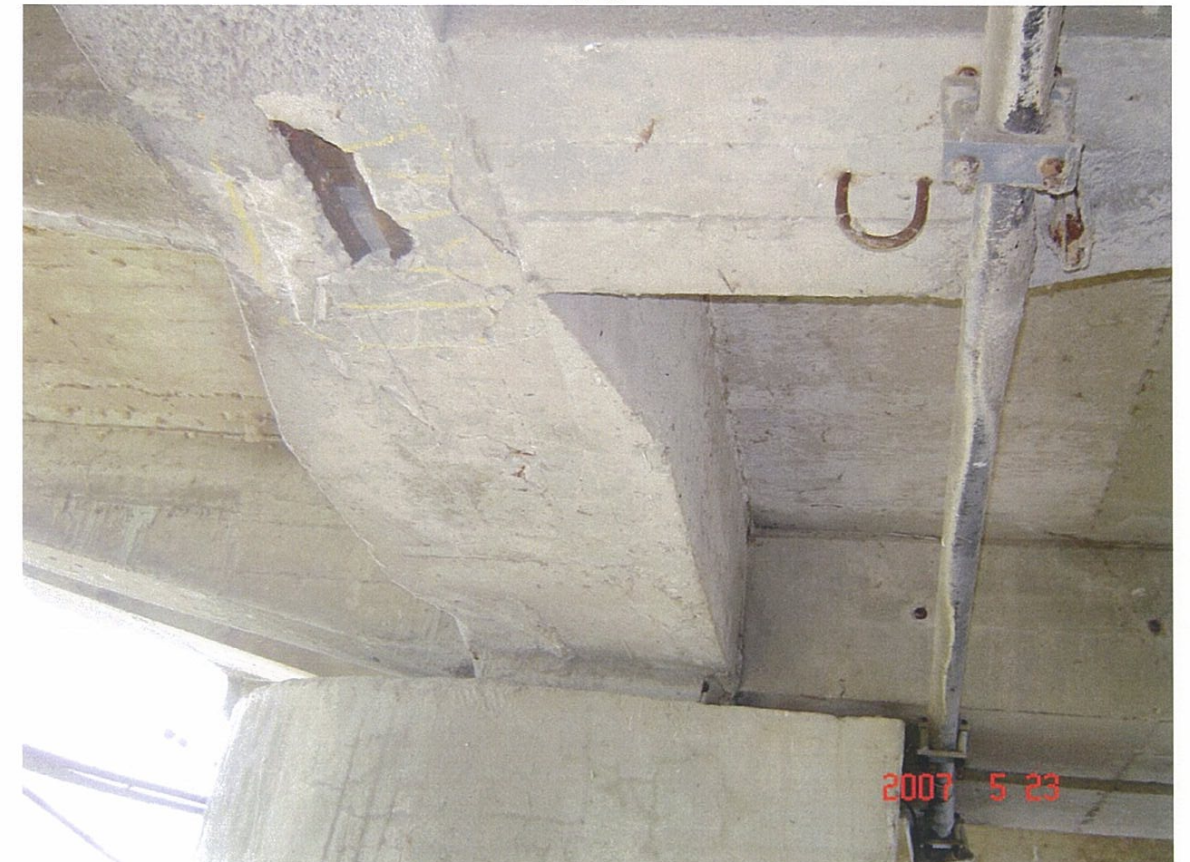
29 Large cavity in bottom E chord, Span 2

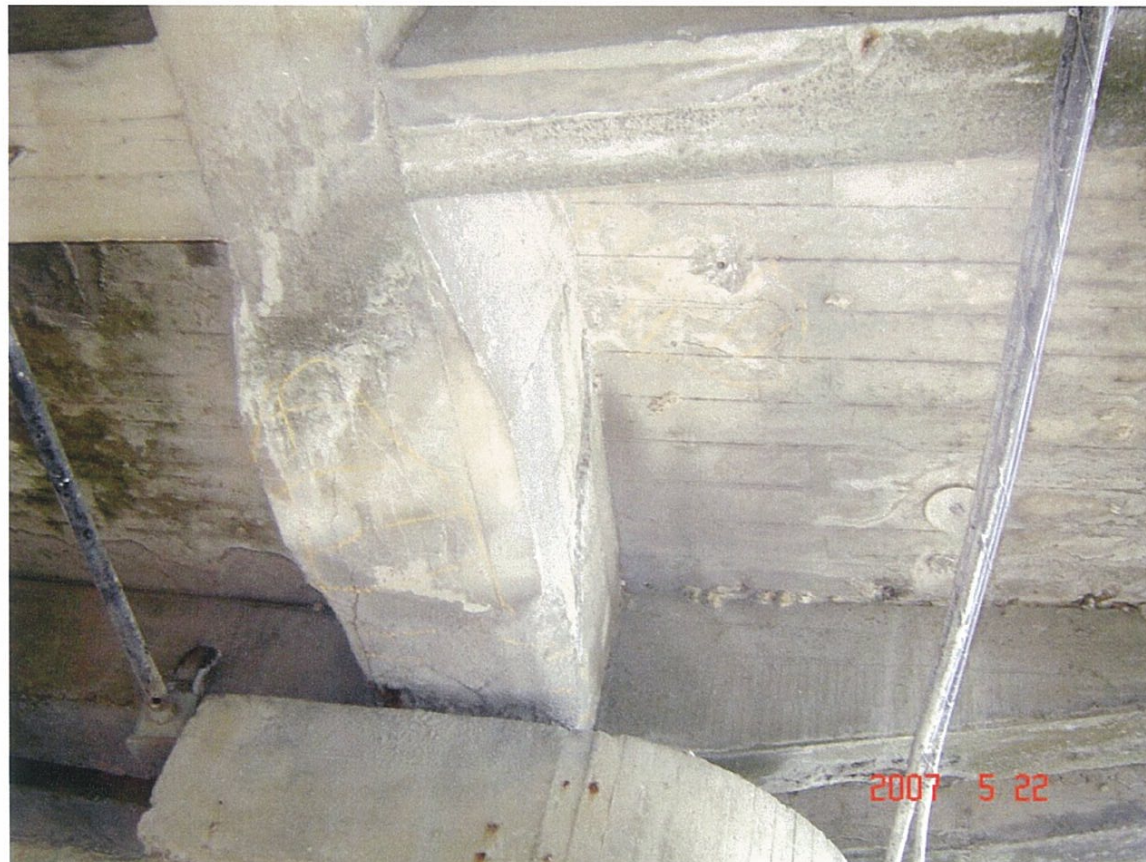
28 Typical cracked & delaminated bottom chord at end, east arch @ Pier 8 shown

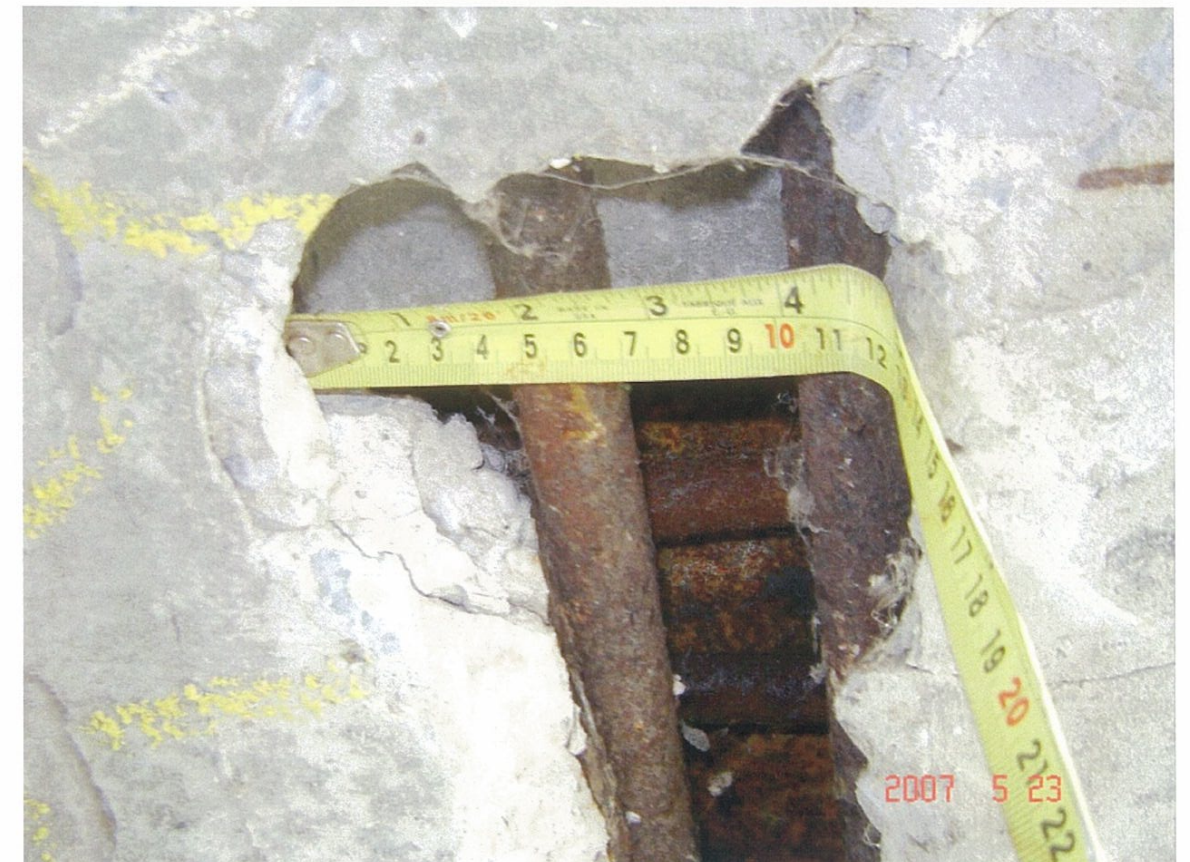
30 Exposed bars in cavity in bottom E chord, Span 2

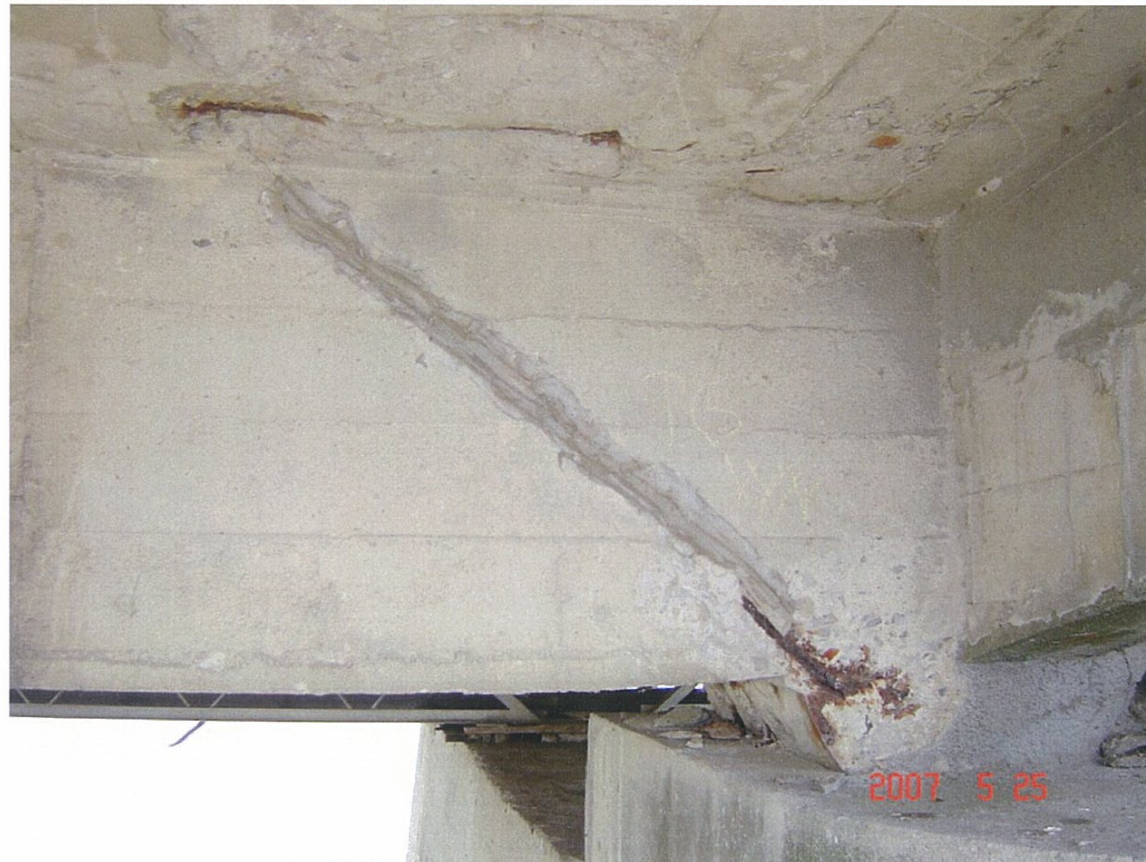
and the abutment ends; many of these cracks were routed and caulked (Photo 31), except for the cracks at Pier 1 (north side, east and west chords, Photo 32), Pier 4 (south side, west chord), and at Piers 6 and 7 (north side, east chords). It should be noted that the diagonal crack at the end of the bottom chord appeared to coincide with the location of an exposed bent steel plate for rebar anchorage observed at Pier 7, east side (Photos 33 and 34). A localized severe honeycombing pocket showing large cavity or hole, approximately 130mm x 300mm opening size, was found on the underside of the east bottom chord at junction with a floor beam north of Pier 2; several layers of light to medium rusted rebars were visible in the cavity (Photos 29 and 30). All concrete end floor beams between the bottom chords at the piers and the abutments were completely reconstructed during the 1983 bridge rehabilitation and are generally in good condition. The exterior end floor beams below the sidewalks, however, appeared to have been replaced in places, where not replaced, the exterior floor beams were found patched with shotcrete; cracks, delamination, and spalls were generally noted on the original patched end floor beams (Photo 34). Several of the intermediate floor beams are in poor condition with severe cracks, delamination, and spalls, particularly the beams at Span 2 (Photos 35 and 36).

31 Sealed diagonal crack in west bottom chord west of Pier 6 (TYP)

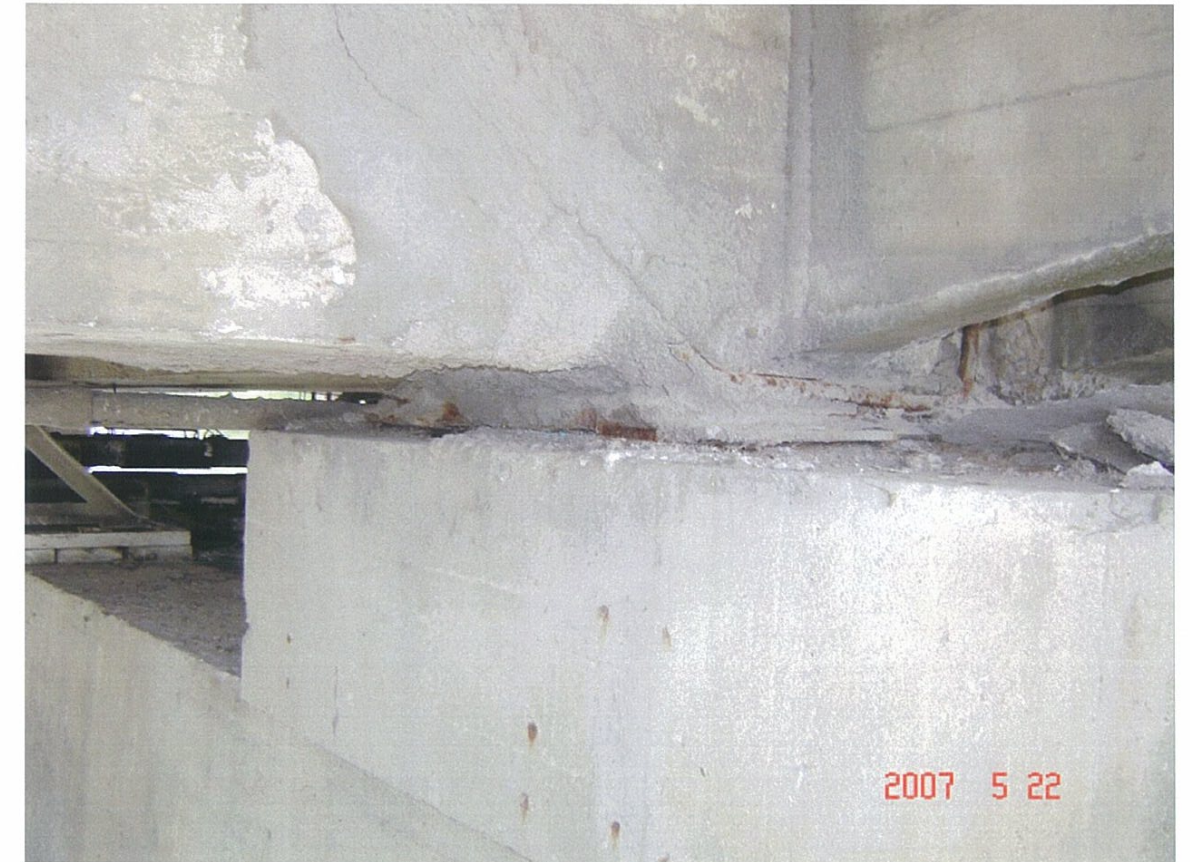
33 Exposed bent steel anchorage plate at north end of Span 8 bottom east chord, Pier 7

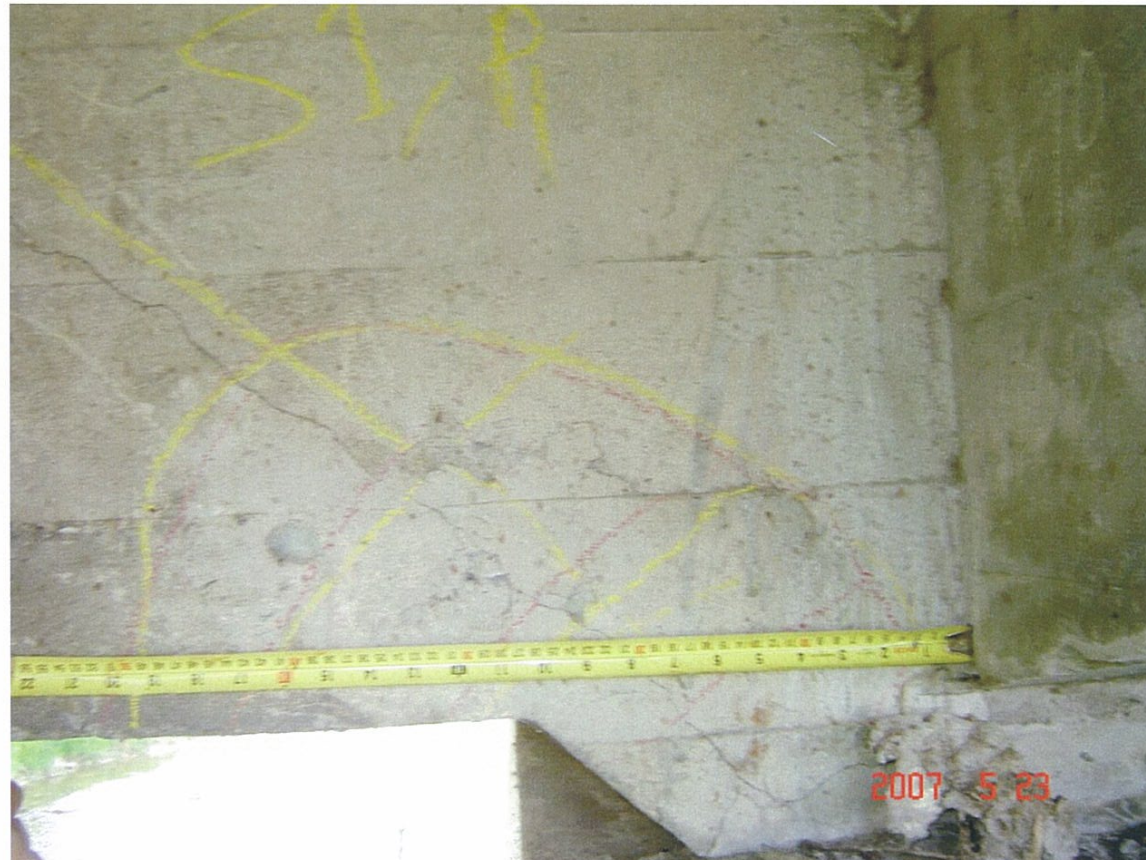
32 Diagonal crack on bottom west chord, south of Pier 1 (TYP)

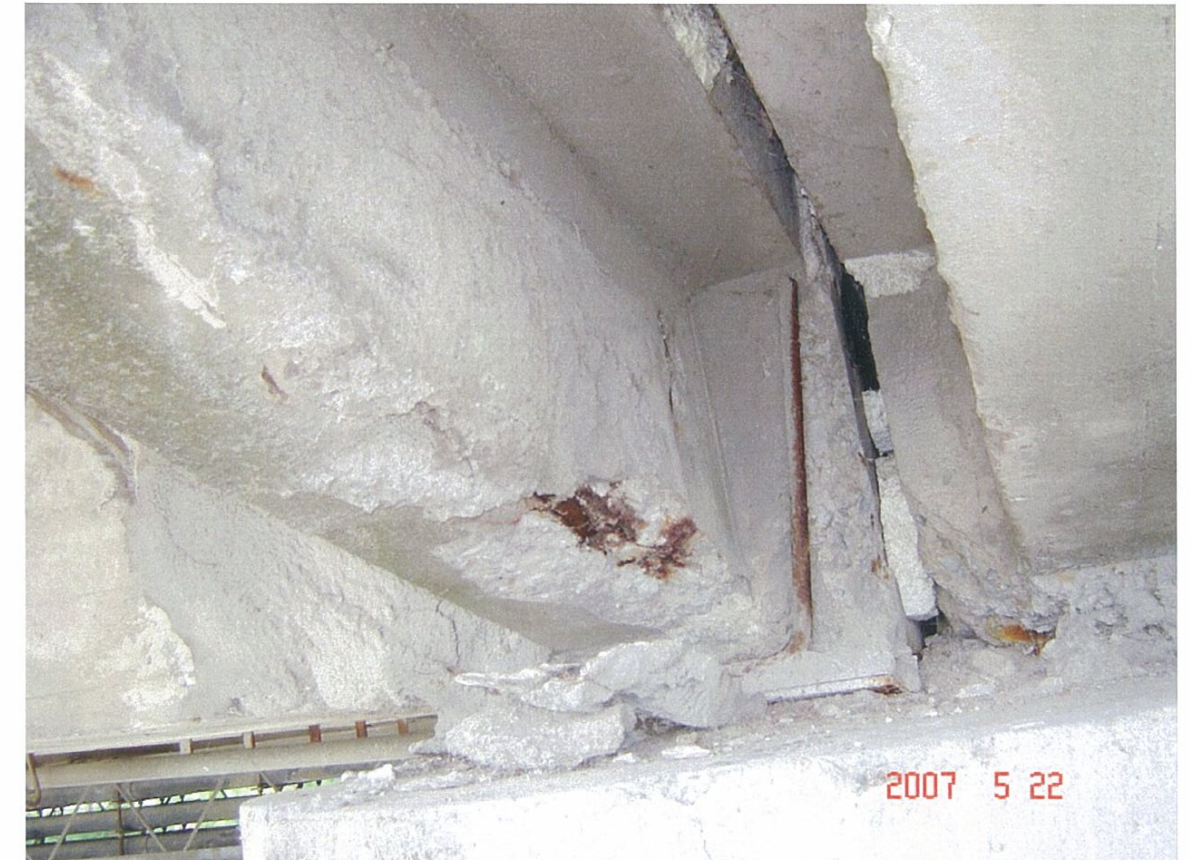
34 Spalled on floor beam under east sidewalk at Pier 7 (TYP)

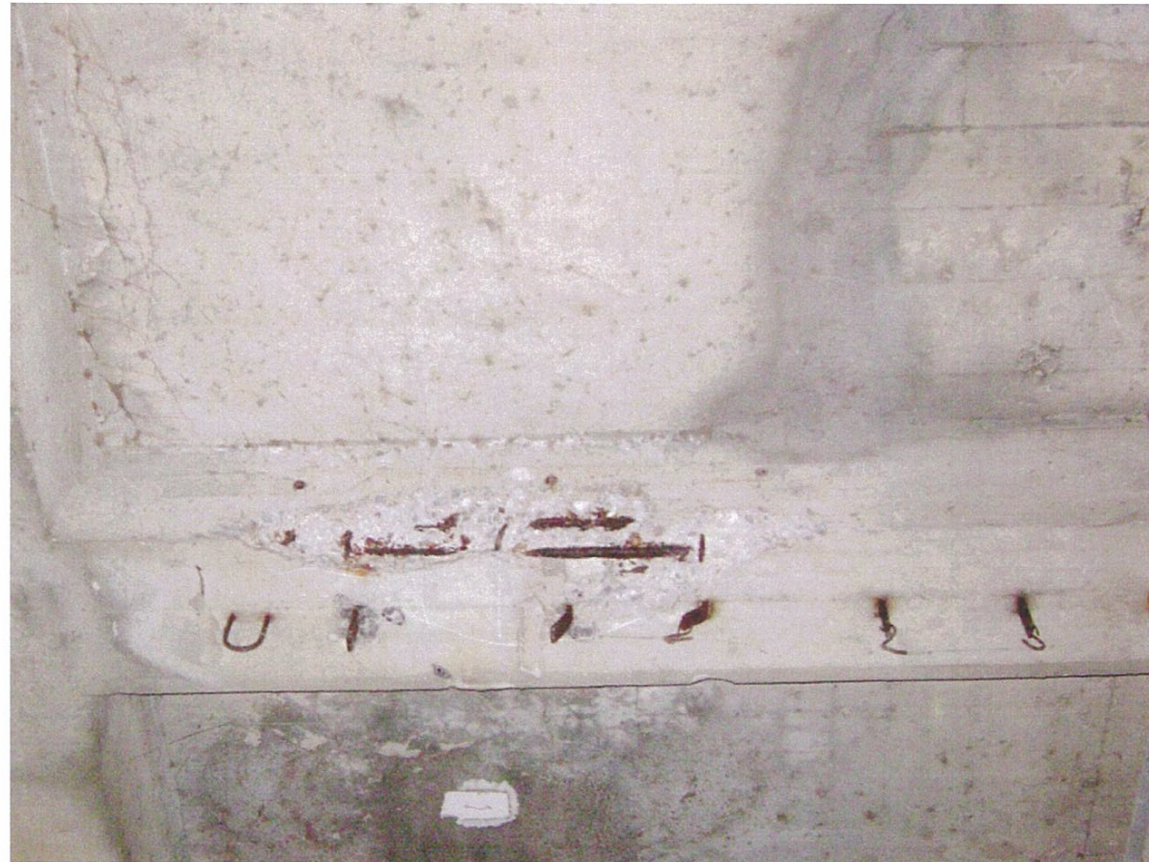
35 Typical spalled on intermediate floor beam

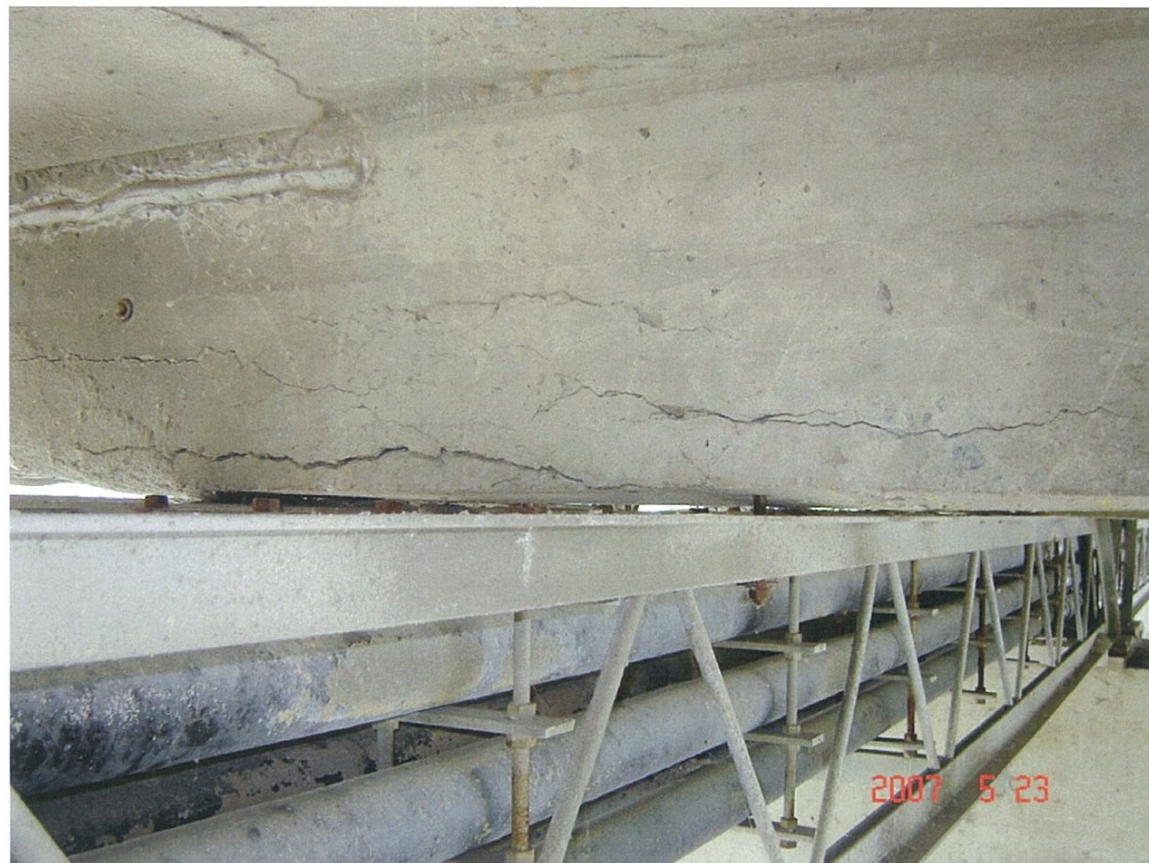
Several of the intermediate floor beams are in poor condition with severe cracks, delamination, and spalls, particularly the beams at Span 2

36 Cracked and delaminated interior floor beam at Span 2
