DETAILED BRIDGE DECK
CONDITION SURVEY

Argyle Street South Bridge
Old Highway 6 over the Grand River
Caledonia, Haldimand County

Site #9-002

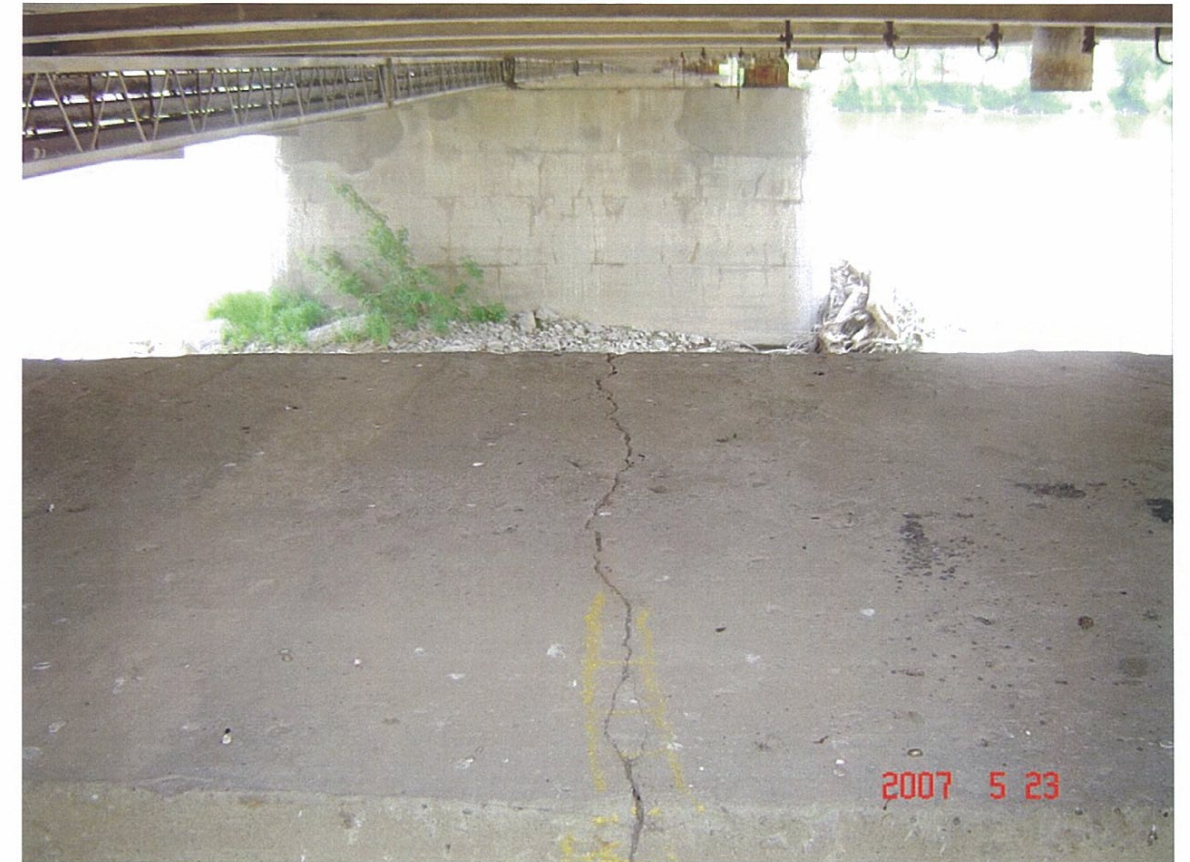
were also found extending between the construction joints or from the joints to the top bearing seat or the ground surface. A wide crack, extending from north to south faces, was noted on the upper portion of Pier 2 (Photo 41). Shallow spalled or severe scaling pocket was noted on the top central bearing seat of Pier 6 (Photo 42). Rocks and boulders for scour protection are presented at all the piers. Numerous graffiti presents on both abutment walls. At the south abutment end, the south embankment slope is covered with a timber boardwalk for pedestrian crossing under the bridge (Photo 50); large concrete blocks are present for the protection of the south embankment slope below the bridge deck (Photo 47). There is no slope protection on the embankment at the north abutment end.

41 Wide crack across top of Pier 2

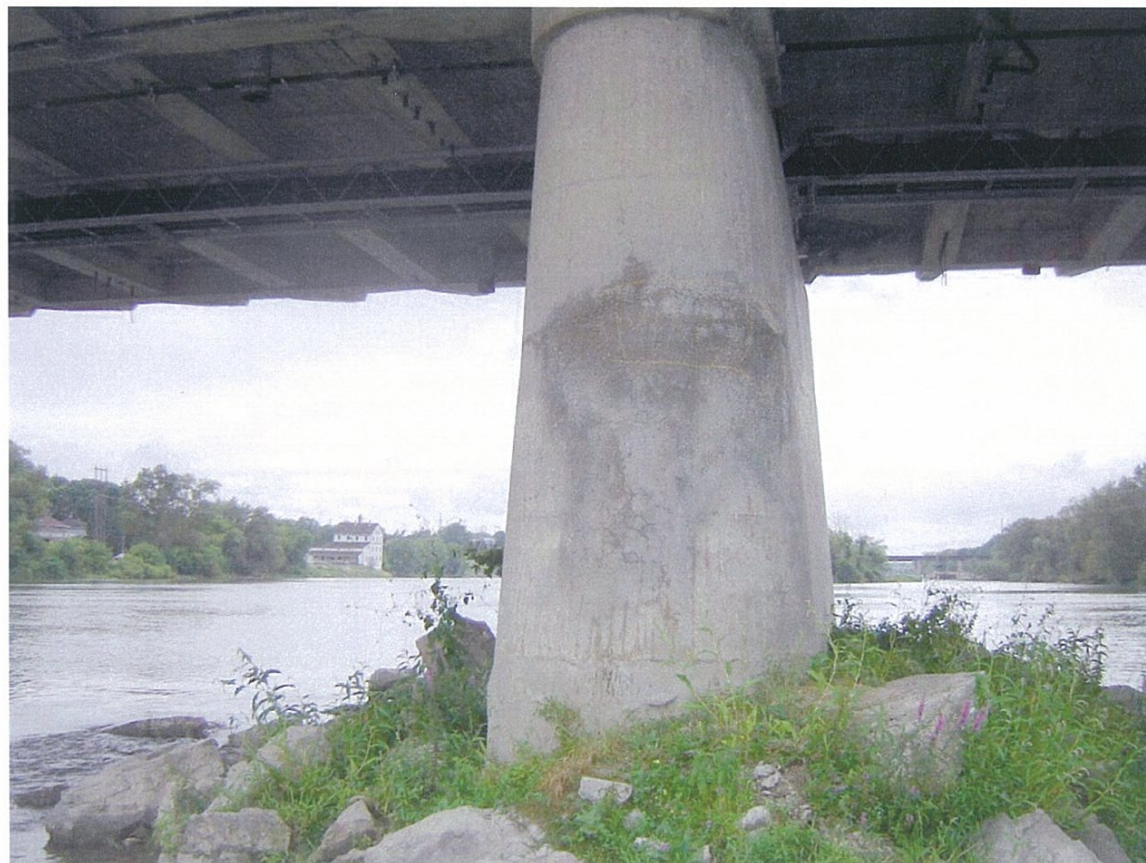
40 Localized delamination on east side of Pier 5 (TYP)

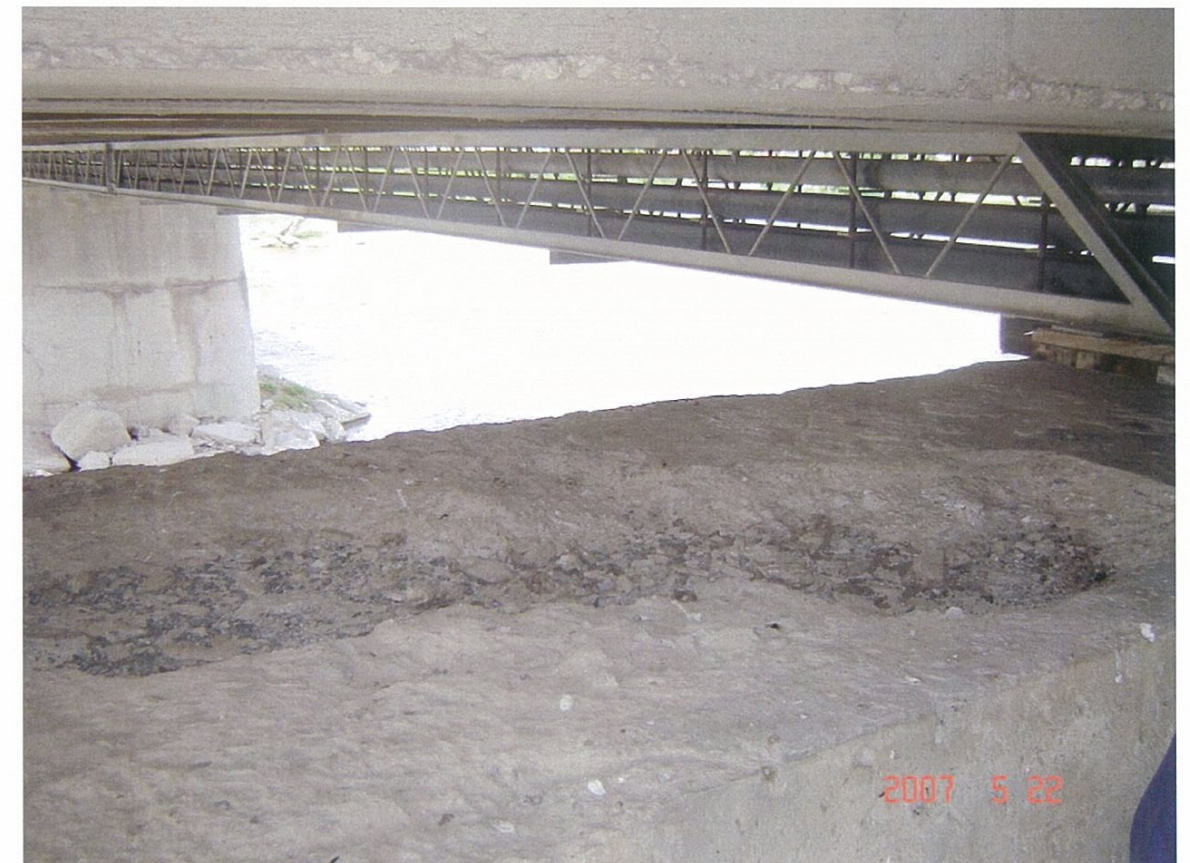
42 Local shallow spalled atop Pier 6
