**DETAIL FOUNDATION INVESTIGATION REPORT  
REHABILITATION OF THE ARGYLE STREET SOUTH BRIDGE  
FORMER HIGHWAY 6, CALEDONIA, SITE 9-2  
GWP 3147-06-00, AGREEMENT NO. 3006-E-0049  
MINISTRY OF TRANSPORTATION, ONTARIO  
– SOUTHWESTERN REGION**

January 2, 2008

07-1130-023-0  
Geocres No. 30M4-111

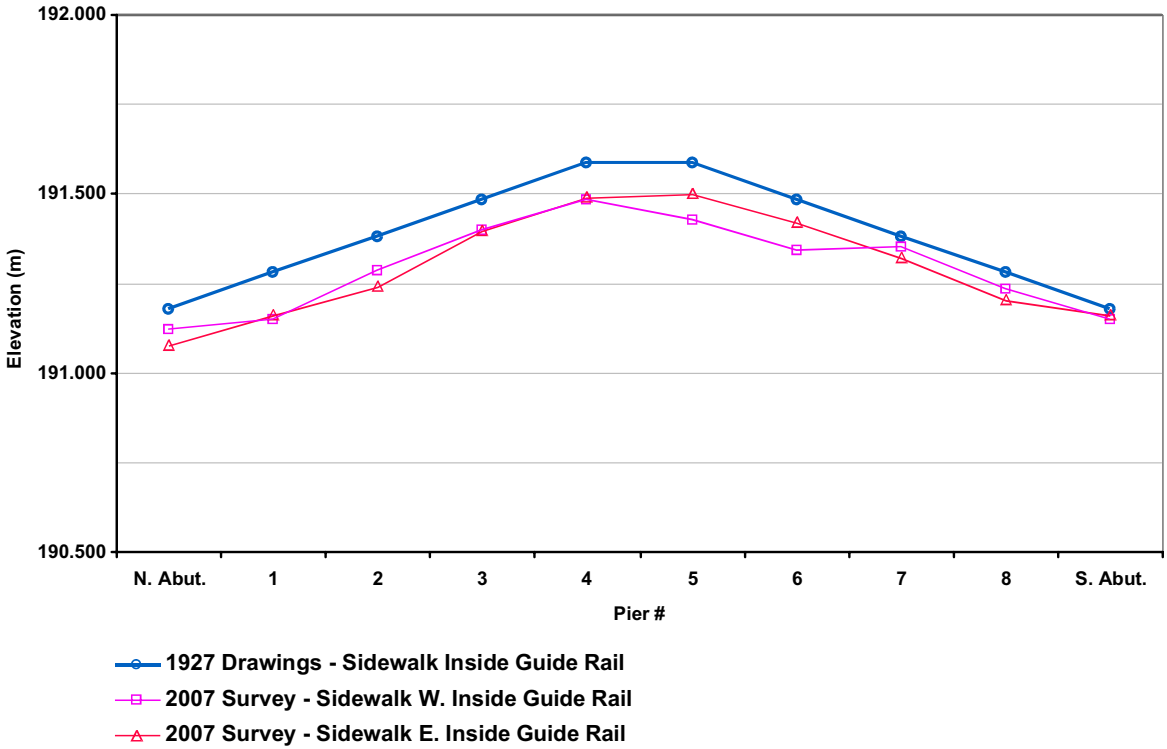
| CHECK | | | | FIGURE 4 |

The post construction settlement estimated from the current survey data and the 1927 design drawings are provided in Table I together with the related rock parameters for the founding stratum. These data indicate average foundation settlements of up to 94 millimetres with differential settlements of as much as 80 millimetres at individual piers or abutments.

Figure 4 provides a plot of the estimated settlements along the profile of the bridge and Figure 5 presents a frequency histogram of the transverse differential settlement of foundation units.
