THE STAGE 2 ARCHAEOLOGICAL ASSESSMENT OF
THE ARGYLE STREET BRIDGE,
CALEDONIA, TOWN OF HALDIMAND

P.I.F. # P035-038-2007

November-2007

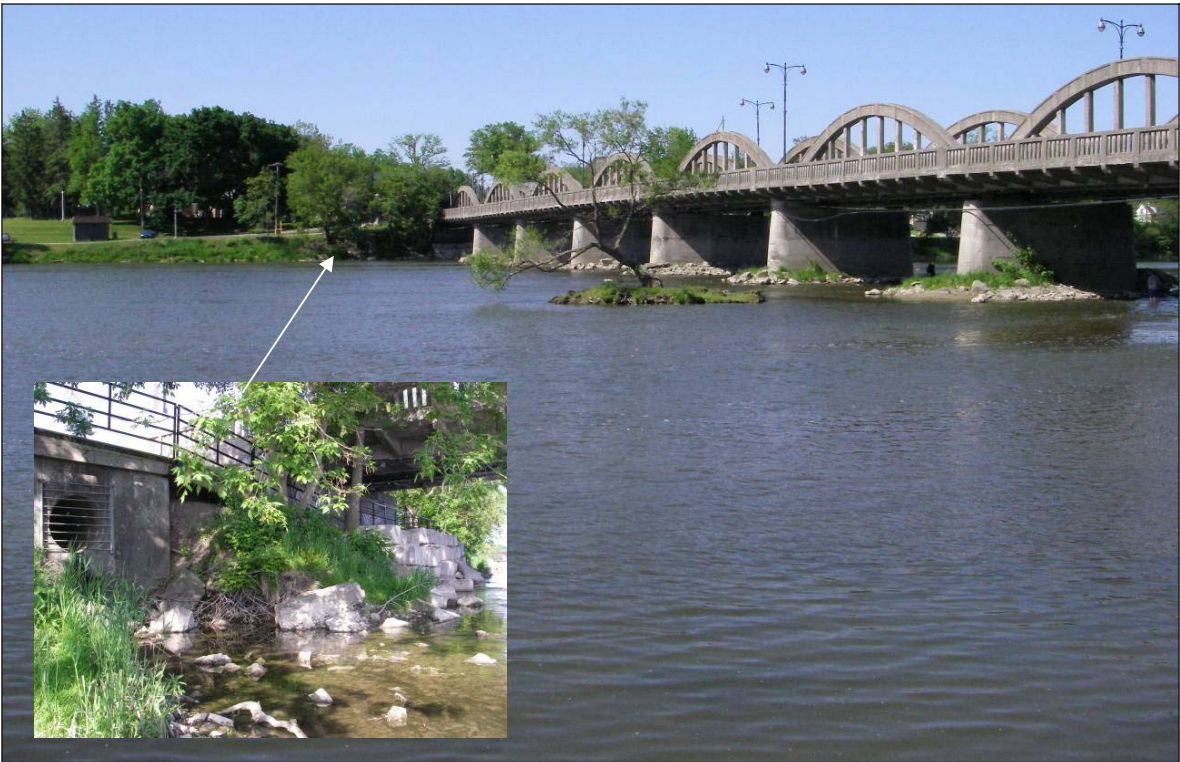
Figure 3: View looking south bank of Grand River with inset showing some of the bank disturbances.

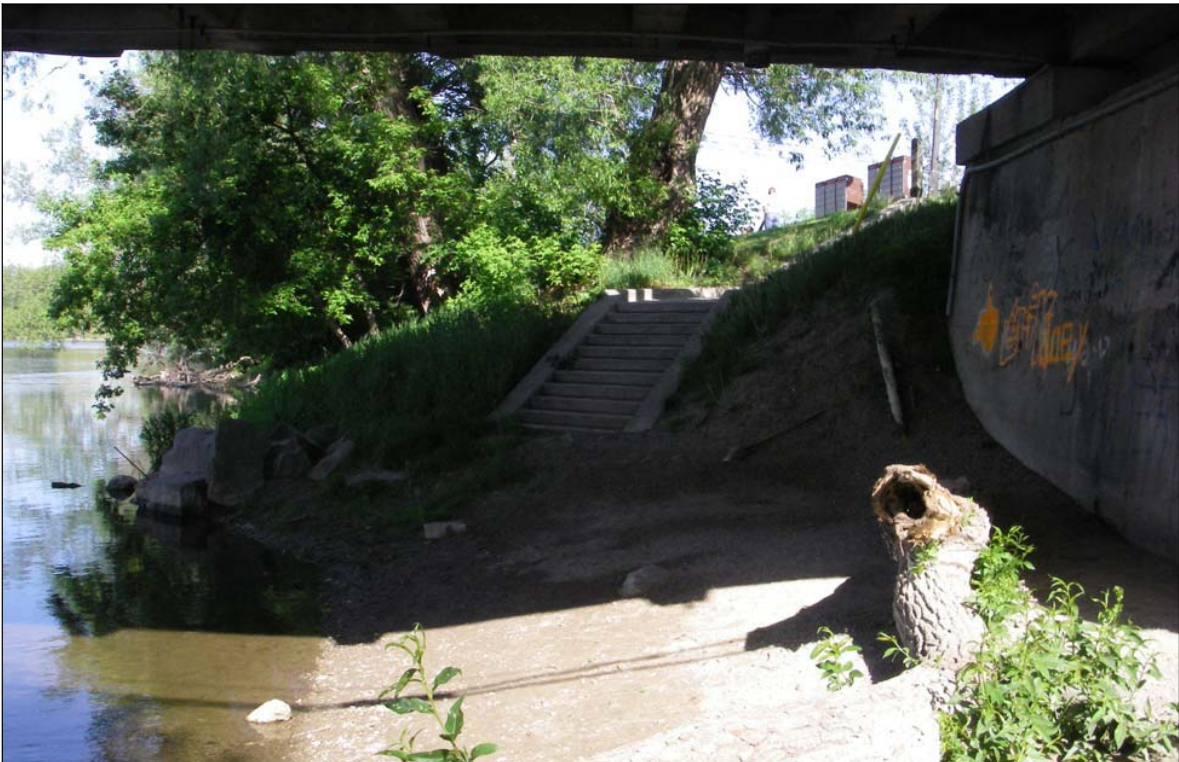
Figure 5: North end of bridge looking west at abutment, steps and riverbank.

The three shovel test pits were excavated along the north river bank on the west side of the bridge (Figure 5). The soil encountered was a mix of dark brown silt and crushed gravel with chunks of concrete and asphalt (Figure 6). The test pits were excavated to a depth of 25 to 30 cm before large pieces of concrete and asphalt prevented further excavation. These large chunks are interpreted as part of the large-scale filling that has occurred to help control erosion from ice jams and flooding. Although the soil matrix was interpreted as part of the fill, it was screened and inspected for artifacts in case material from lower levels had been incorporated. A single shovel test pit was attempted on the east side of the bridge below the Toll Keeper’s house but the large chunks of concrete and asphalt were impenetrable. Although no intact original topsoil was encountered, no evidence was found that would preclude the possibility of such a layer partially present beneath the fill. No archaeological remains were encountered.
