HERITAGE ACT ASSESSMENT OF THE

CALEDONIA

ONTARIO CONSOLIDATED REPORT MARCH 2008 (REVISED MAY 2009)

Heritage Impact Assessment of the Argyle Street Bridge Caledonia, Ontario

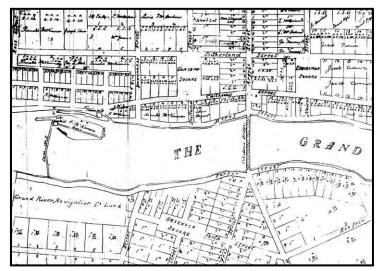
Figure 5: "Caledonia c.1850" showing 1843 bridge. Plan reproduced from the Caledonia Tweedsmuir History.

The first bridge over the Grand River at Caledonia was erected in 1843 (Figure 5). It was on the plank road between Hamilton and Port Dover, built by the provincial government and finally completed in 1846. It was a toll road with seven toll gates. In 1851, the Commissioners of Public Works gave up control of the road and bridge and leased out their operation. The road, including the bridge, was sold to Z.B. Choate and Samuel Kern in 1865⁶

The Caledonia bridge was 638 feet long and 16 feet wide and consisted of six fixed spans and one moveable span on the east bank. The moveable bridge was for the passage of barges and vessels on the Grand River Navigation Canal.⁷

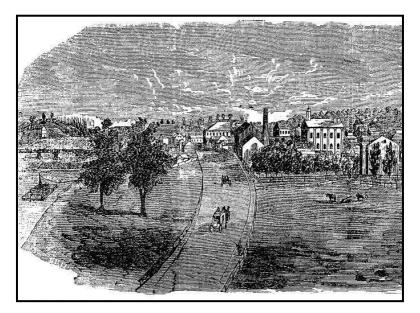
Figure 7: Approaching Caledonia C.W. from the East, Canadian Illustrated News, Oct.24, 1863. Source: deVolpi, The Niagara Peninsula – A Pictorial Record, 1966.

the bridge as it existed in 1863. The bridge is depicted on the left side of the illustration. It seems to consist of short spans resting on large timber cribs. The detail is too hazy to determine the type of span. This appears to be the earliest image of the bridge. This may be the standing remains of the bridge or indicate that the replacement had been built earlier. In any case, two spans of this new bridge were destroyed in 1870 and subsequently replaced. Finally, in the mid-1870s, the County of Haldimand made funding available for a substantial metal bridge.⁸

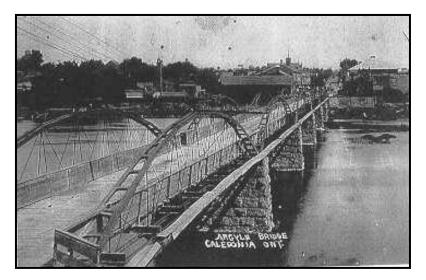
Plate 1: The 1875 six-span iron bowstring arch bridge, Caledonia

In 1875, a six-span iron bridge replaced the 1865 structure (Plate 1 and Figure 8). By then, navigation on the Grand River in this area had virtually ended. Thus, the County of Haldimand was able to build a new bridge without the swing span for vessels.

Each span of the new bridge was 105 feet (32 m) long. The bowstring truss was made of wrought iron and fabricated at the Scott Foundry in Caledonia. It had a wood deck and a six-foot wide wooden sidewalk along the west side. The trusses were supported on masonry piers and abutments. The piers were constructed of large blocks of limestone placed on a footing of large pine timbers. The upstream face of

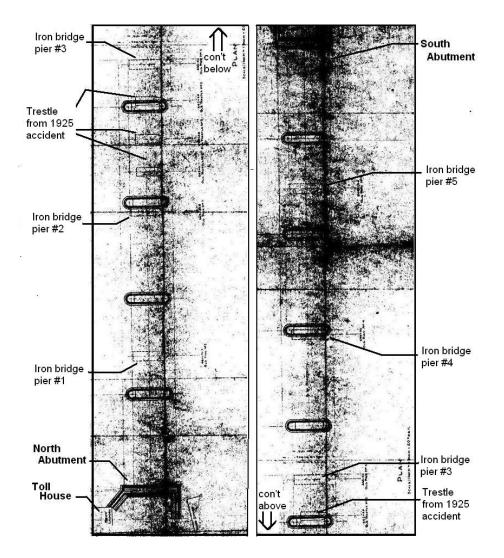
Figure 9: Pier placement showing location of 1875 iron bridge piers and the span destroyed in the 1925 truck accident. Source: MTO drawing 1927

In August 1925, a truck carrying a load of stone caused one of the spans to collapse (Figure 9). The span was replaced with a temporary trestle. The following year, the Ontario Department of Highways assumed responsibility for the road from Hamilton to Port Dover, and it became known as Highway 6. The Department of Highways also assumed the obligation to rebuild the bridge.¹⁰

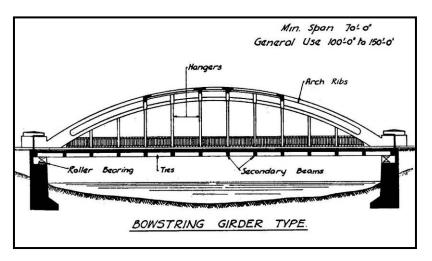
Figure 11: Generic design of a bowstring truss. Source: Legatt, Design and construction of Reinforced Concrete Bridges (1948).

A subsequent development was the concrete bowstring arch (Figure 11). The challenge in designing a bowstring truss was that the bottom cord was in tension (like the string of a bow) which is unsuitable for concrete. To over come this tendency, the deck structure is heavily reinforced with steel. Over time it has been known by a variety of names: Concrete Tied-arch; Rainbow arch (in the United States); Concrete Bowstring girder; Concrete Bowstring truss; and Concrete truss.

The main advantage of the bowstring arch was in comparison to the concrete deck arch. A deck arch requires a relatively high crown in relation to the span. As the span becomes longer, the arch becomes taller. Thus the road surface of a long-span, deck arch over a river, railway or road would be unnecessarily (and expensively) high. The bowstring placed the arch over the deck and hence could be as low as necessary to the obstacle being crossed.

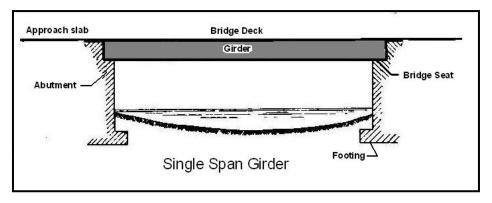
Figure 12: Generic design of a girder span. Source: Legatt, Design and construction of Reinforced Concrete Bridges (1948)

The bowstring arch had a similar advantage over concrete beams which had also been developed about the same time (Figure 12). As the beam span became longer, the depth of the beam also increased. In the case of a bowstring, the arch is "tied" in tension by the bottom cord beam. This beam could be thin because reinforcing steel contained the tensile forces.

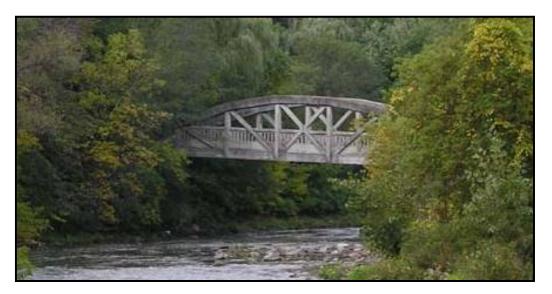
Plate 3: Canadian prototype of the concrete bowstring, Barber and Young, 1909. Source: Andreae, 2006.

The first concrete bowstring in Canada – and possibly the first true use of the design in North America – was completed in 1909 on the Middle Road over Etobicoke Creek in what is now Mississauga (Plate 3). The structure has a 79-foot span and a 16-foot roadway. Remarkably, it survives today.

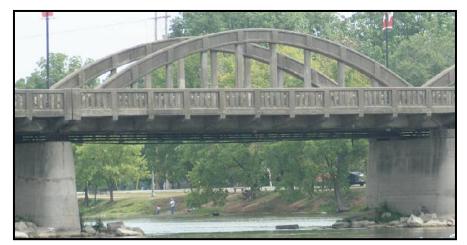
Plate 11: Noth elevation of truss and piers.

The arch appears to be segment of an ellipse rather than a circle. The arch has a low height to length ratio which gives the appearance of a low, flat arch. The beam is heavy with a width of two feet and a depth of 2' 4". The bottom cord is cast as an integral component of the deck, floor beams and arch. The bottom cord is relatively less massive than the arch cord because the tensile strength of the beam is carried by reinforcing steel.

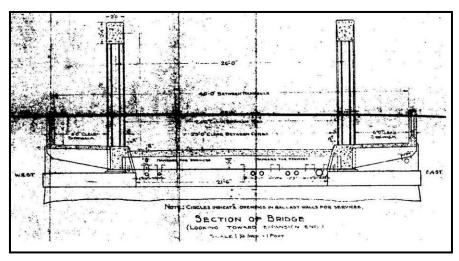
Figure 13: Cross section of bridge, 1927 drawing.

The hanger locations and support posts of the pedestrian railings line up with the floor beams. These beams cast as an integral part of truss. They are cantilevered outside the trusses to support the sidewalks (Plates 12 to 14).

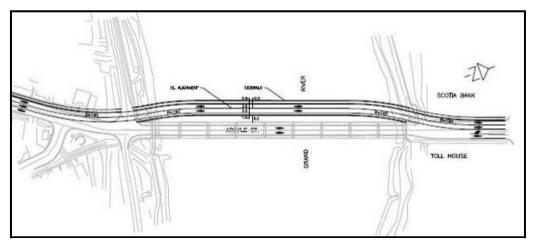
Figure 18: Rehabilitation Alternative 3; two-lane addition

The RH4 alternative is similar to that of RH3 except that a two-lane structure would be constructed span on the west side of the bridge (Figure 18).

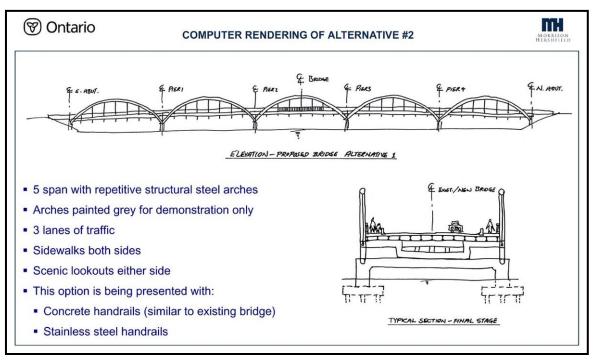
Figure 19: Bridge Replacement Alternative #2

These two alternatives are identical and consist of five steel-arch spans and a three lane cross section (Figure 19). These alternatives differ in construction method. In RP2, one lane of traffic would be maintained during construction. In RP3, traffic would be diverted to a Bailey bridge during the course of construction.
