**DETAIL FOUNDATION INVESTIGATION REPORT  
REHABILITATION OF THE ARGYLE STREET SOUTH BRIDGE  
FORMER HIGHWAY 6, CALEDONIA, SITE 9-2  
GWP 3147-06-00, AGREEMENT NO. 3006-E-0049  
MINISTRY OF TRANSPORTATION, ONTARIO  
– SOUTHWESTERN REGION**

January 2, 2008

07-1130-023-0  
Geocres No. 30M4-111

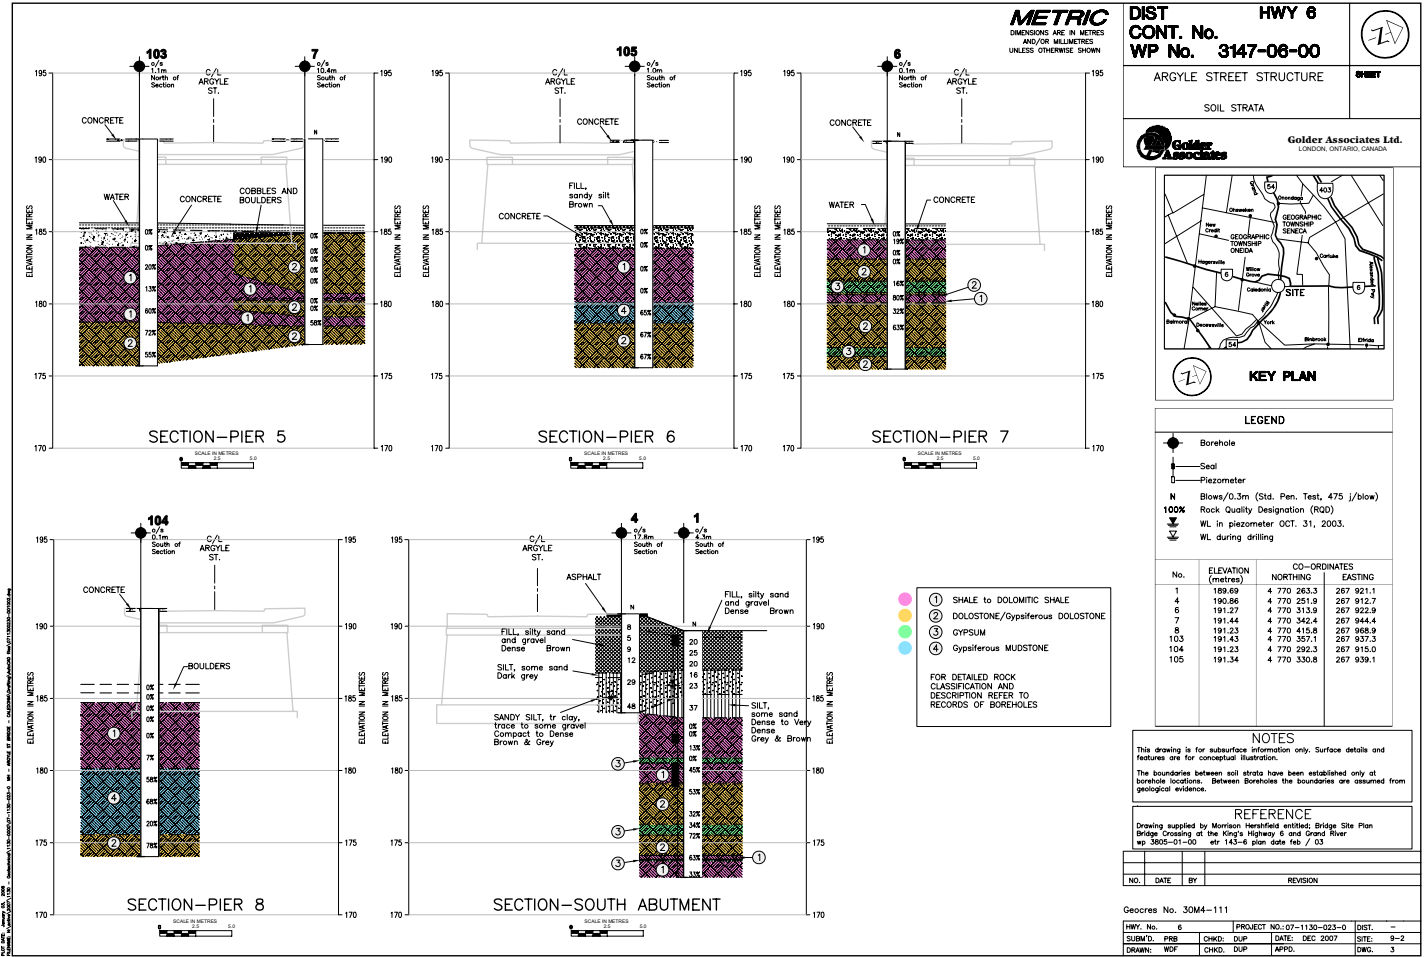
| CHECK | | | | FIGURE 5 |

The post construction settlement estimated from the current survey data and the 1927 design drawings are provided in Table I together with the related rock parameters for the founding stratum. These data indicate average foundation settlements of up to 94 millimetres with differential settlements of as much as 80 millimetres at individual piers or abutments.

Figure 4 provides a plot of the estimated settlements along the profile of the bridge and Figure 5 presents a frequency histogram of the transverse differential settlement of foundation units.
