DETAILED BRIDGE DECK
CONDITION SURVEY

Argyle Street South Bridge
Old Highway 6 over the Grand River
Caledonia, Haldimand County

Site #9-002

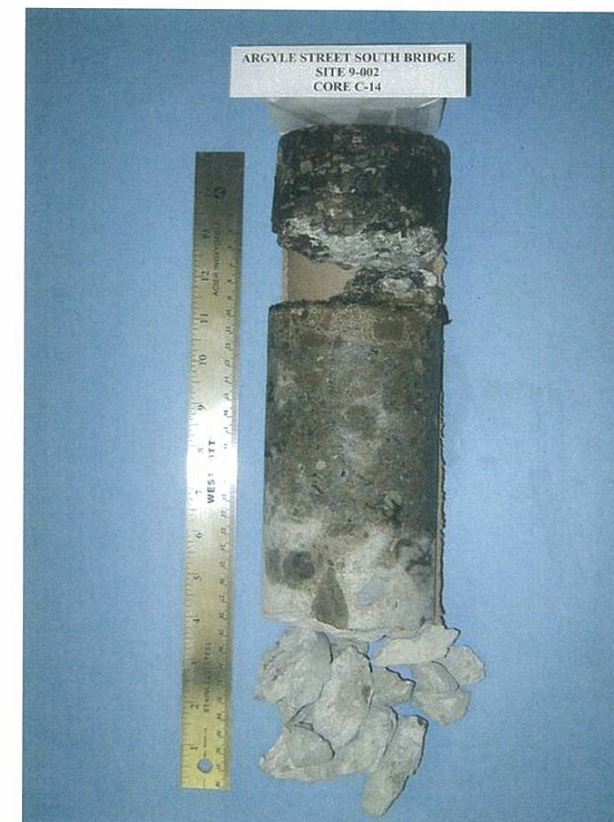
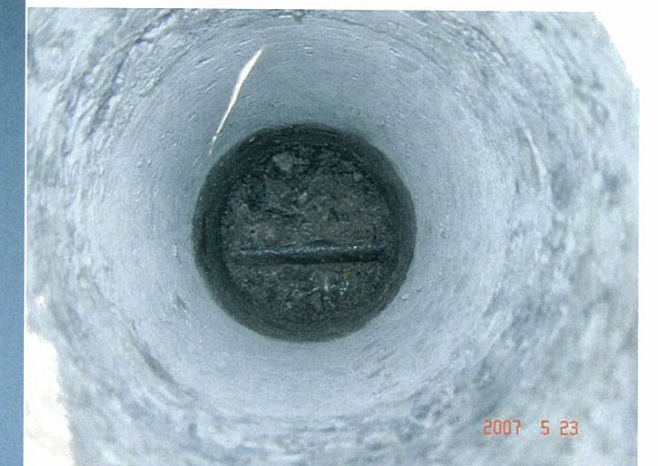
All cores and sawn asphalt samples showed no significant defects on the top concrete overlay layer, except for a narrow longitudinal crack at the top 20mm of the overlay in Core C-14 and a narrow transverse crack at the bottom 110mm in Core C-9. No significant deterioration of the original concrete deck below the overlay layer in any of the core samples.

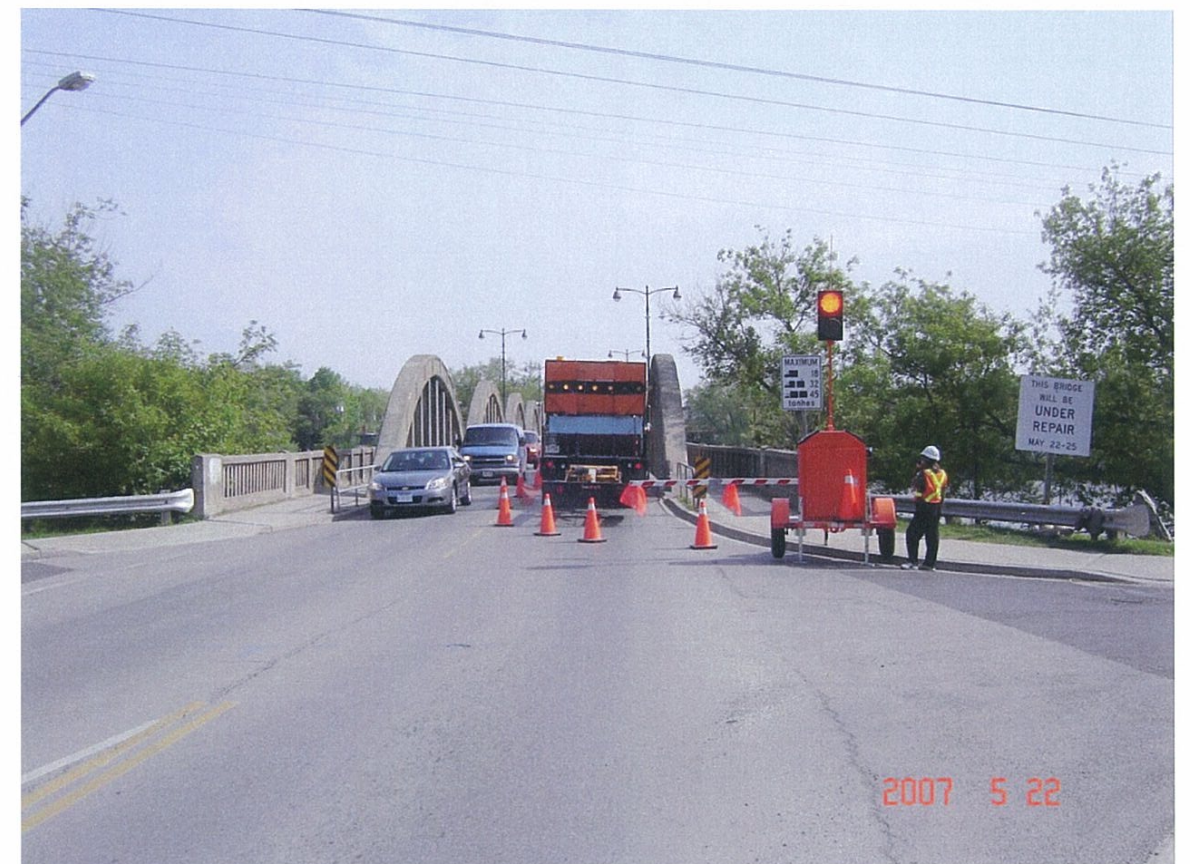
02 Bridge from South Approach

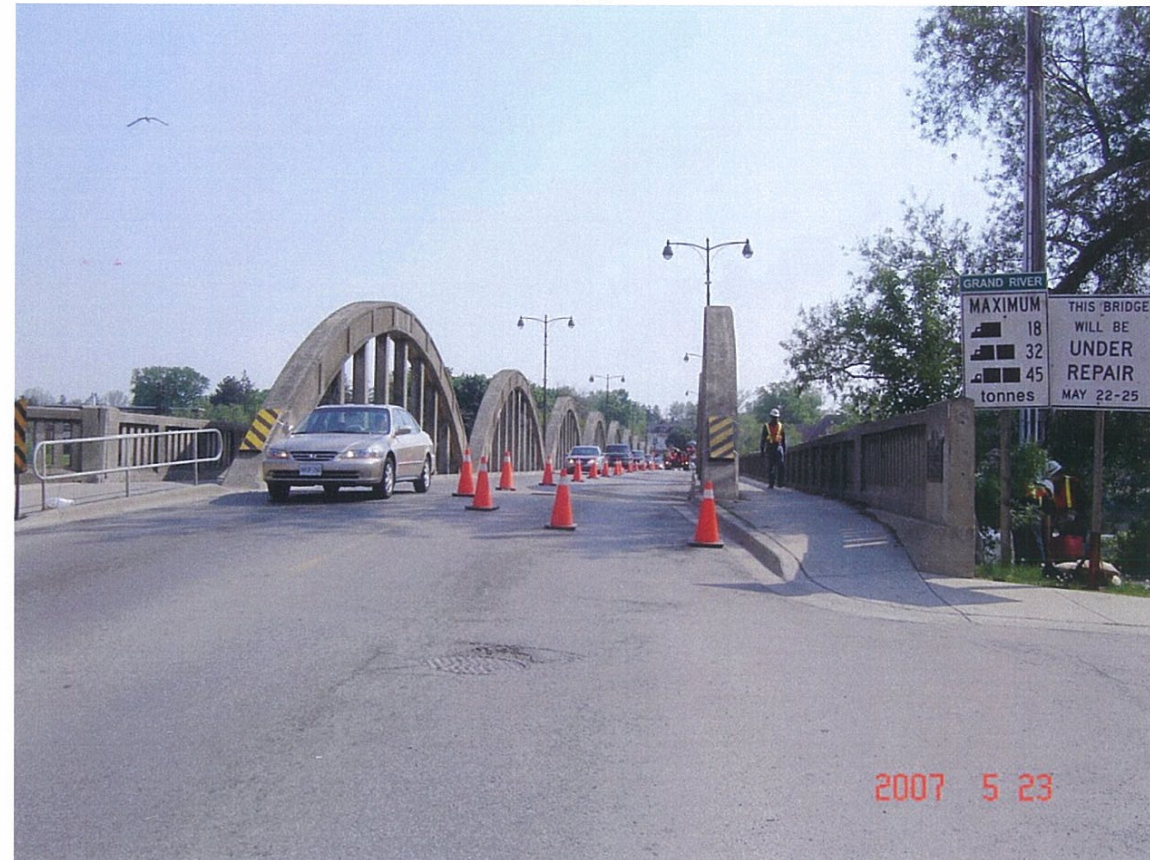
03 Bridge from North Approach

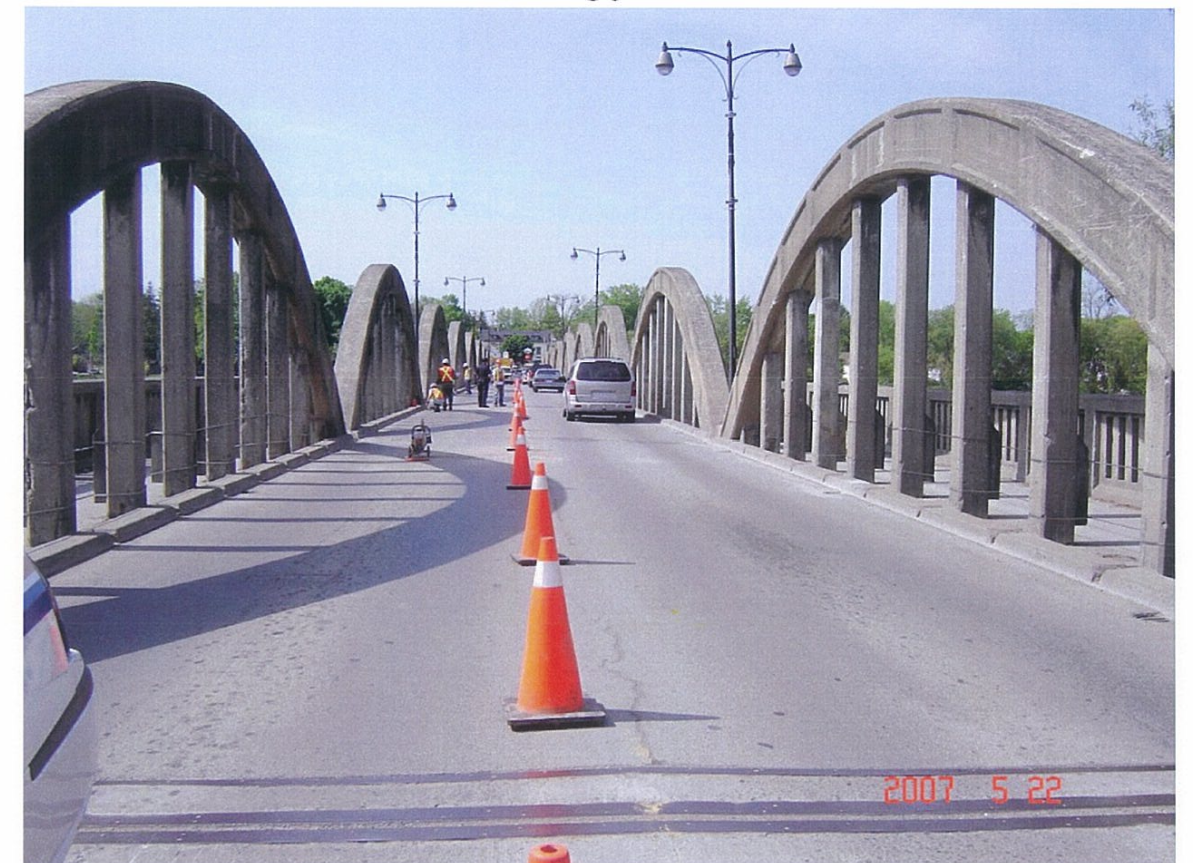
05 Deck asphalt surface from North end

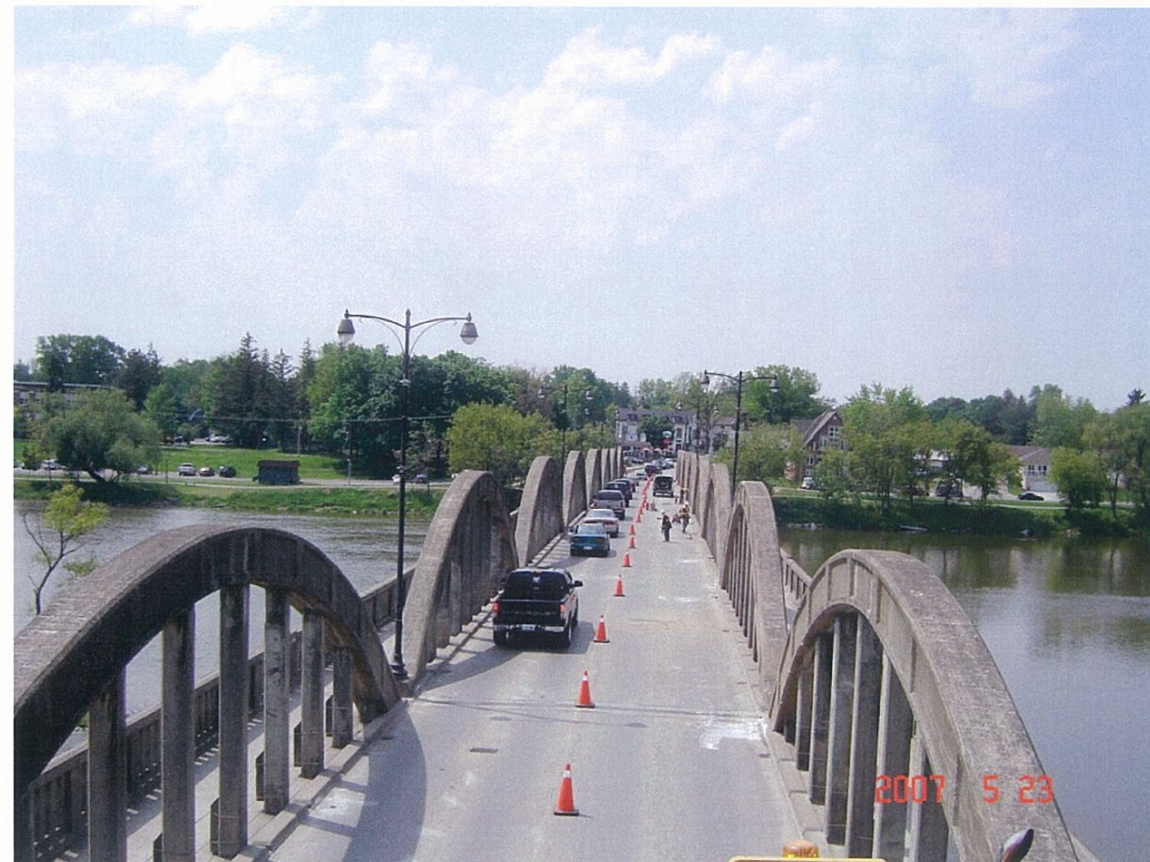
04 General view of deck, looking South

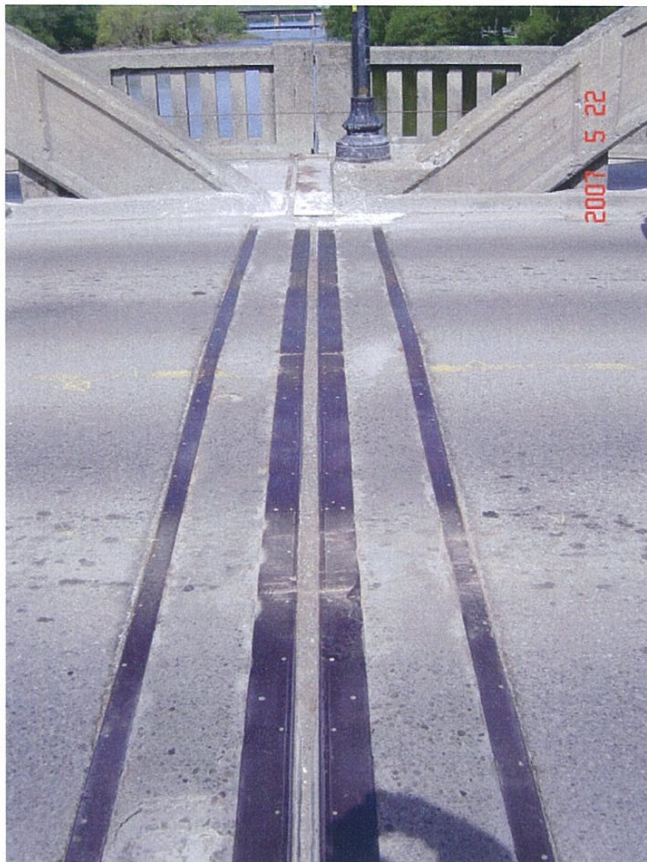
08 Typical Expansion Joint at Piers

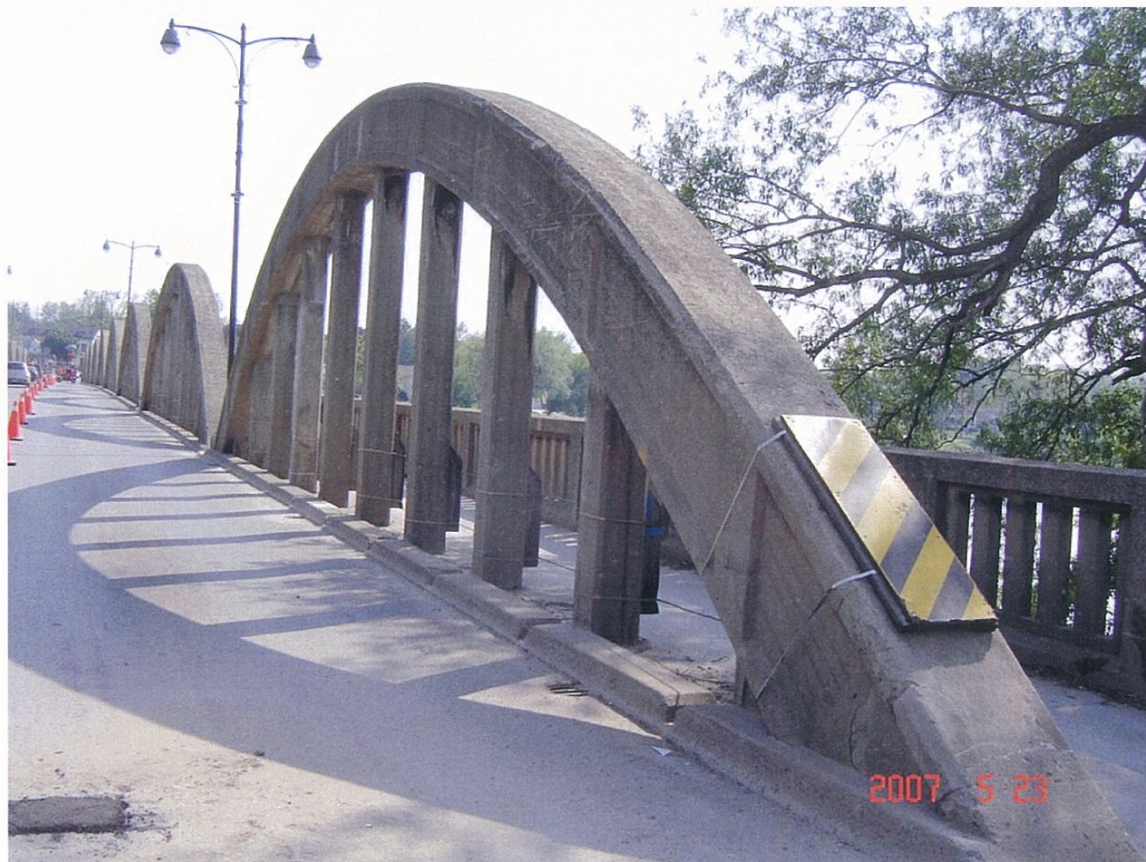
12 General view of Arch at deck surface (west arch, looking south shown)

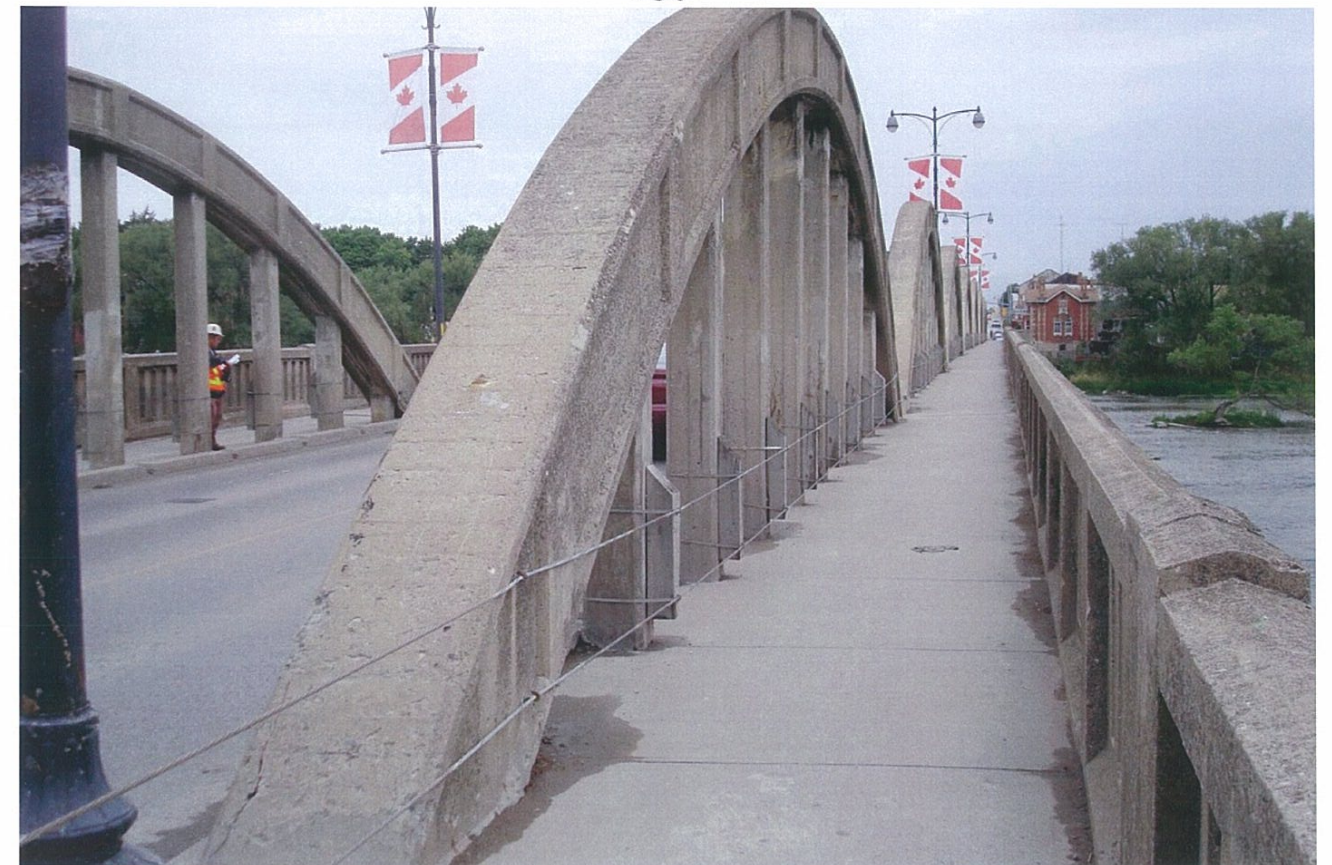
17 East Sidewalk, looking North

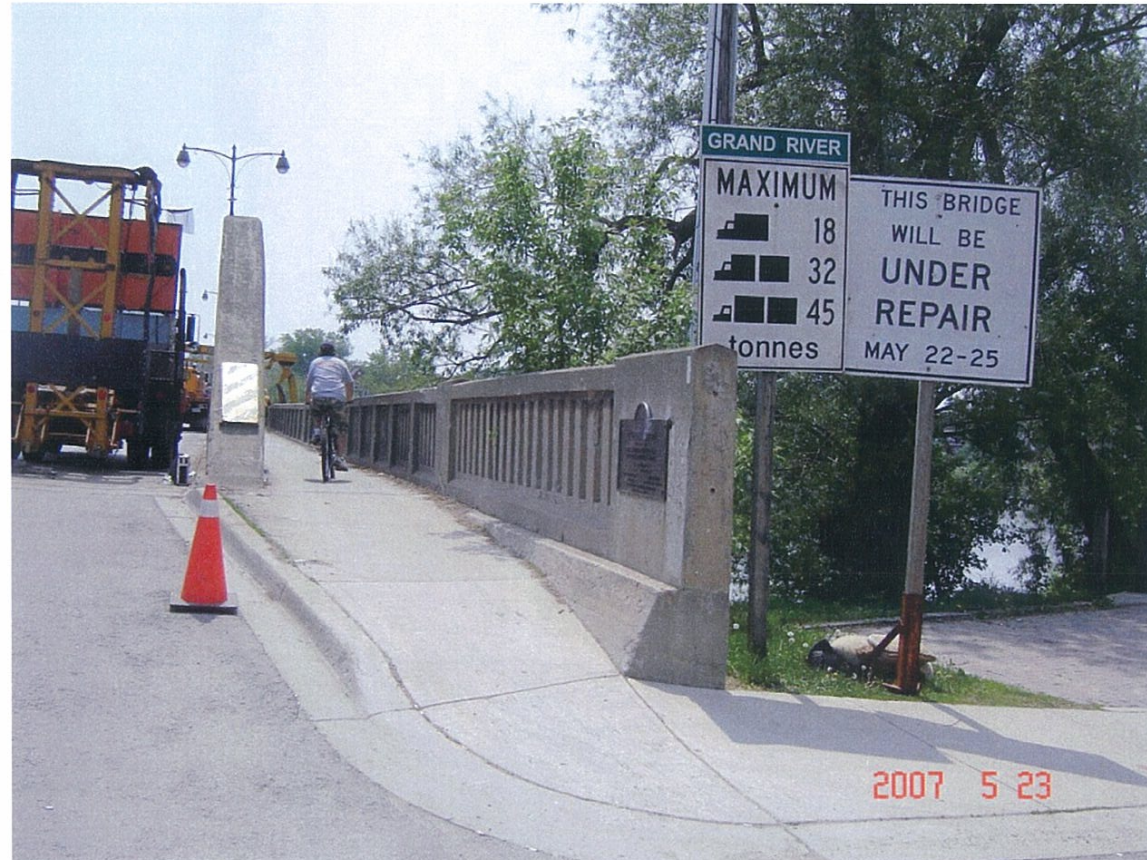
16 West Sidewalk, looking South

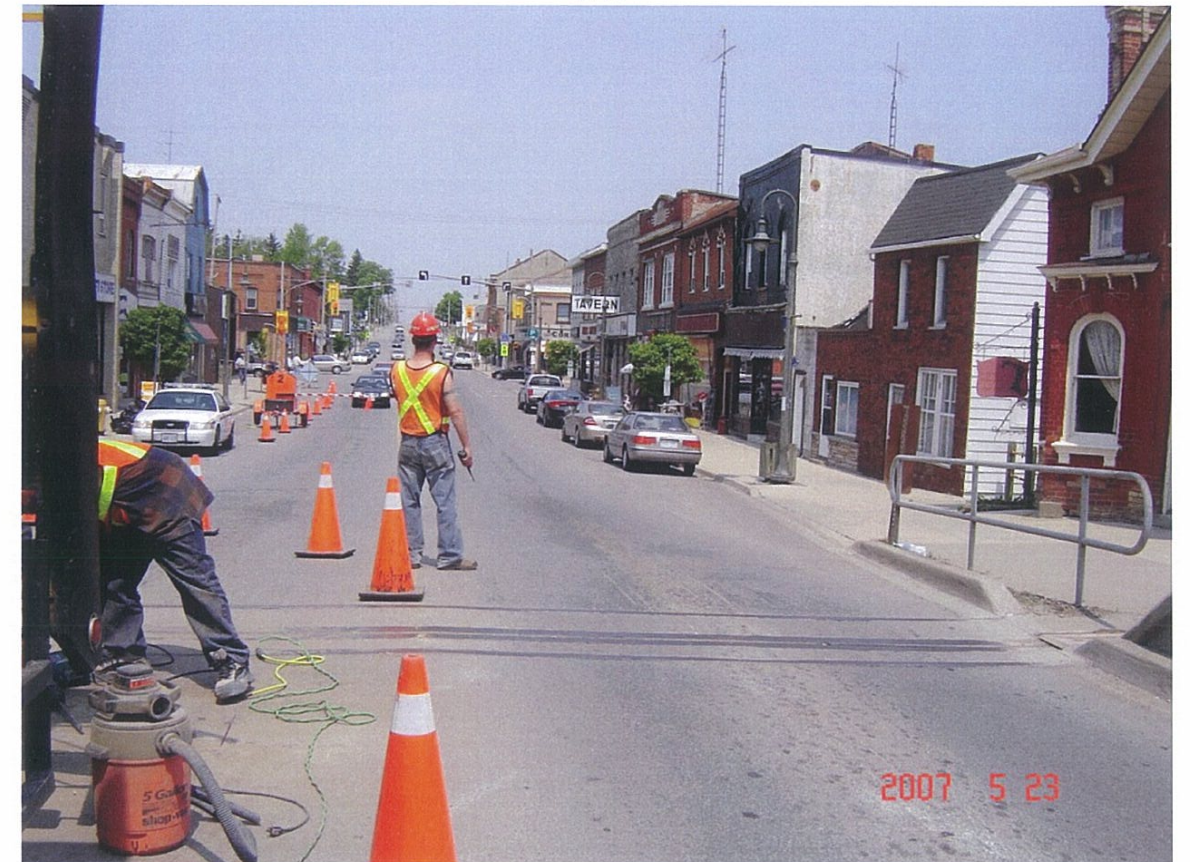
21 North Approach

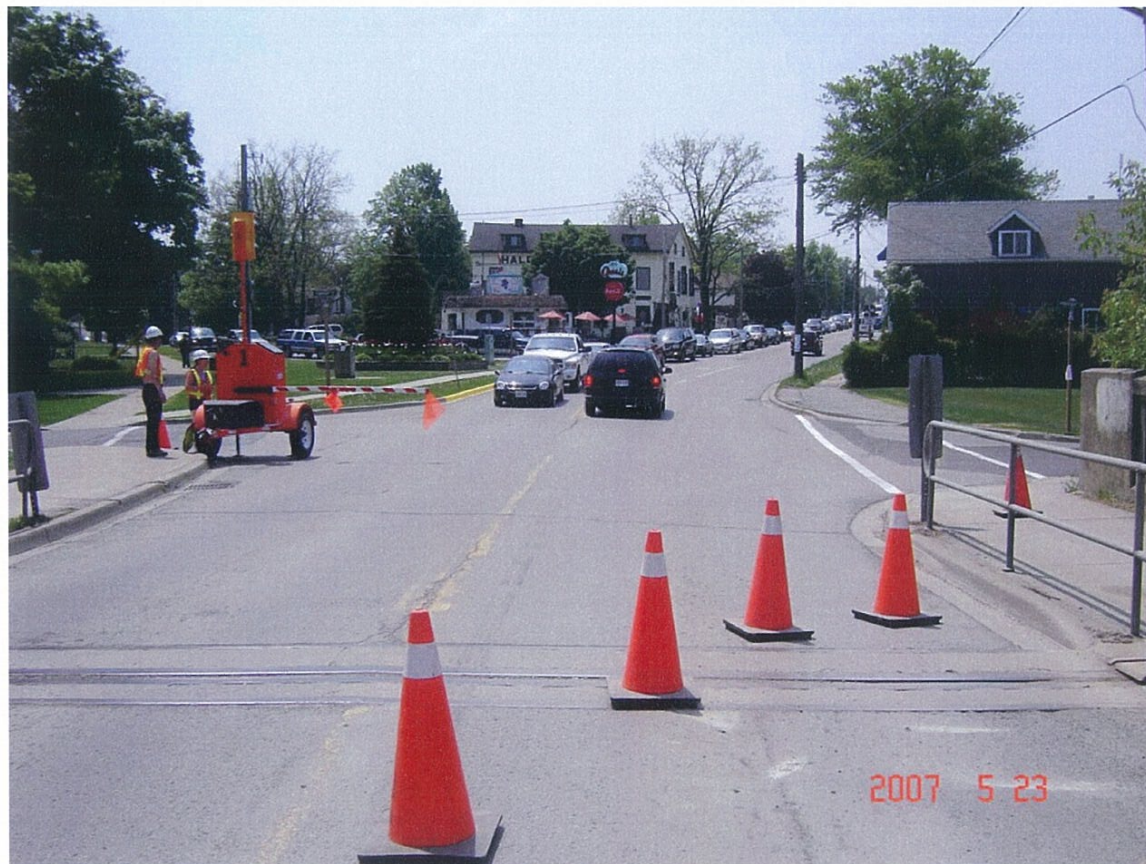
20 South Approach

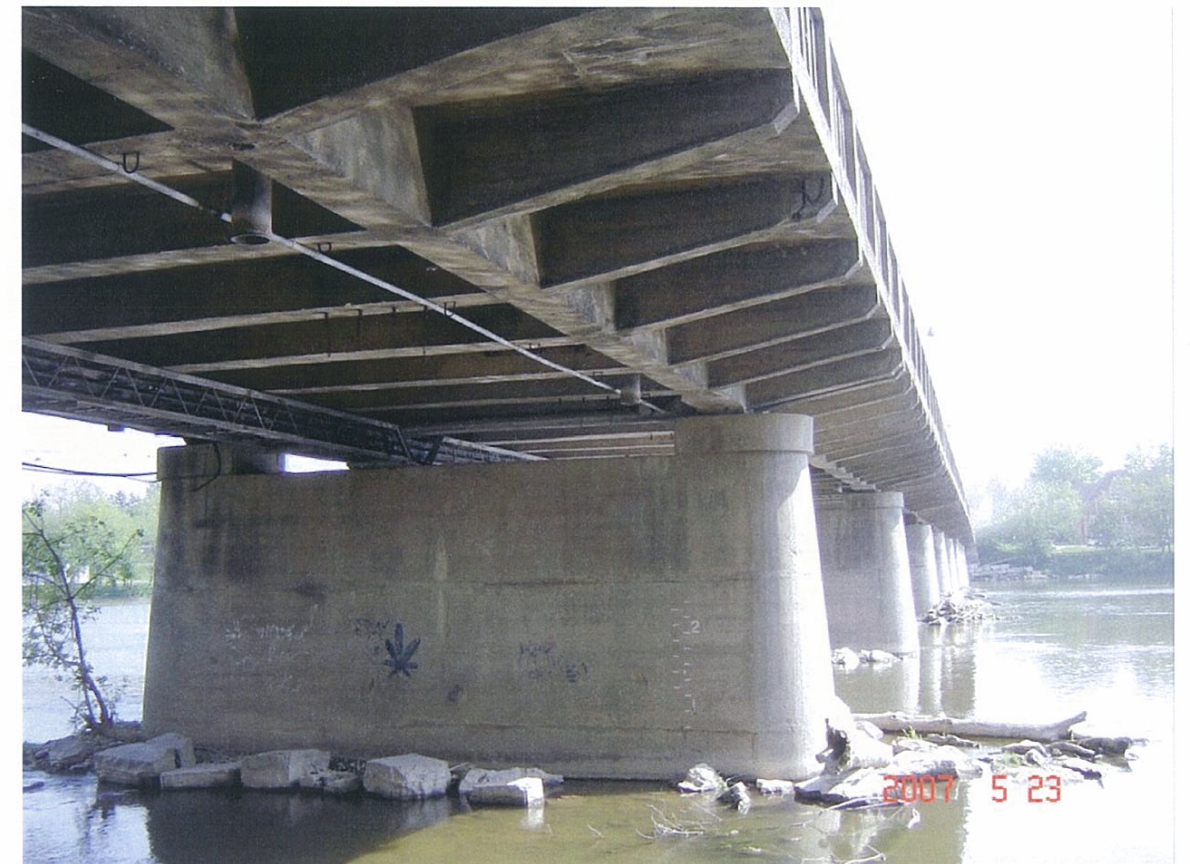
22 General view of deck underside, looking South

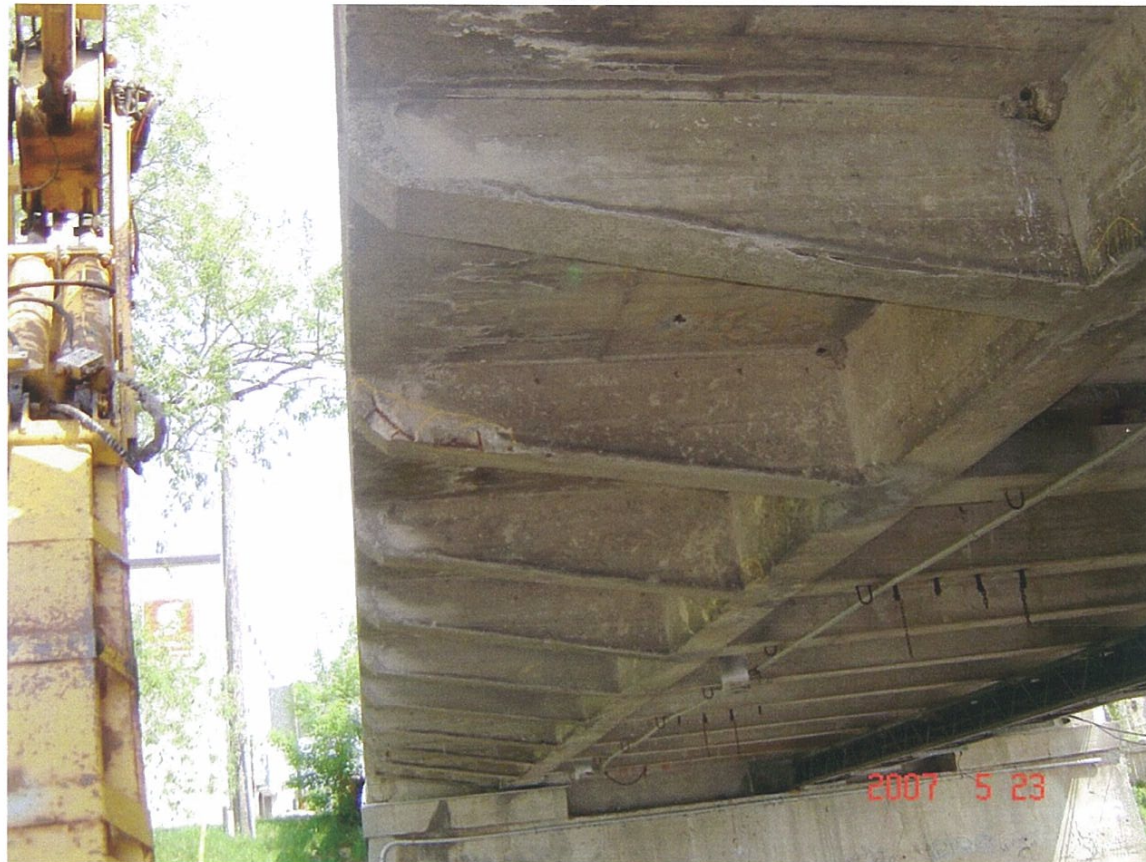
23 Typical exterior soffit

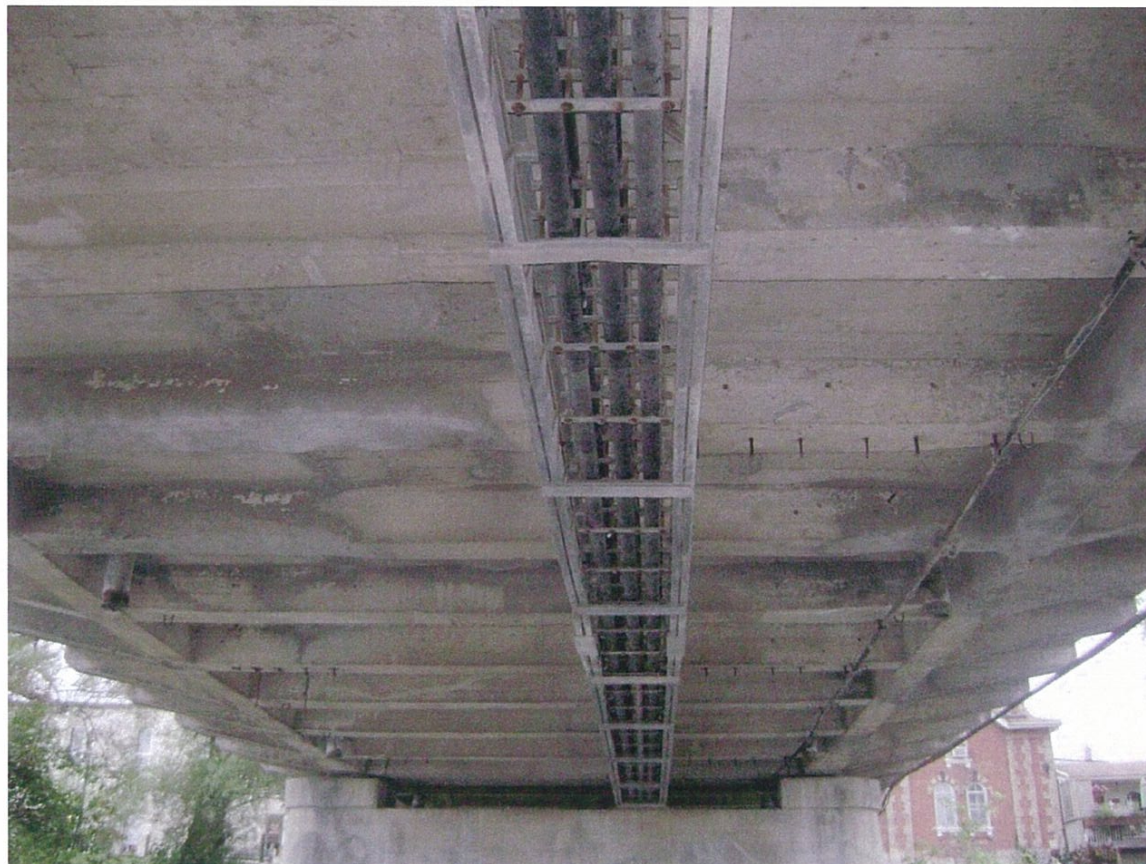
24 Typical interior soffit, Span 2 from south shown

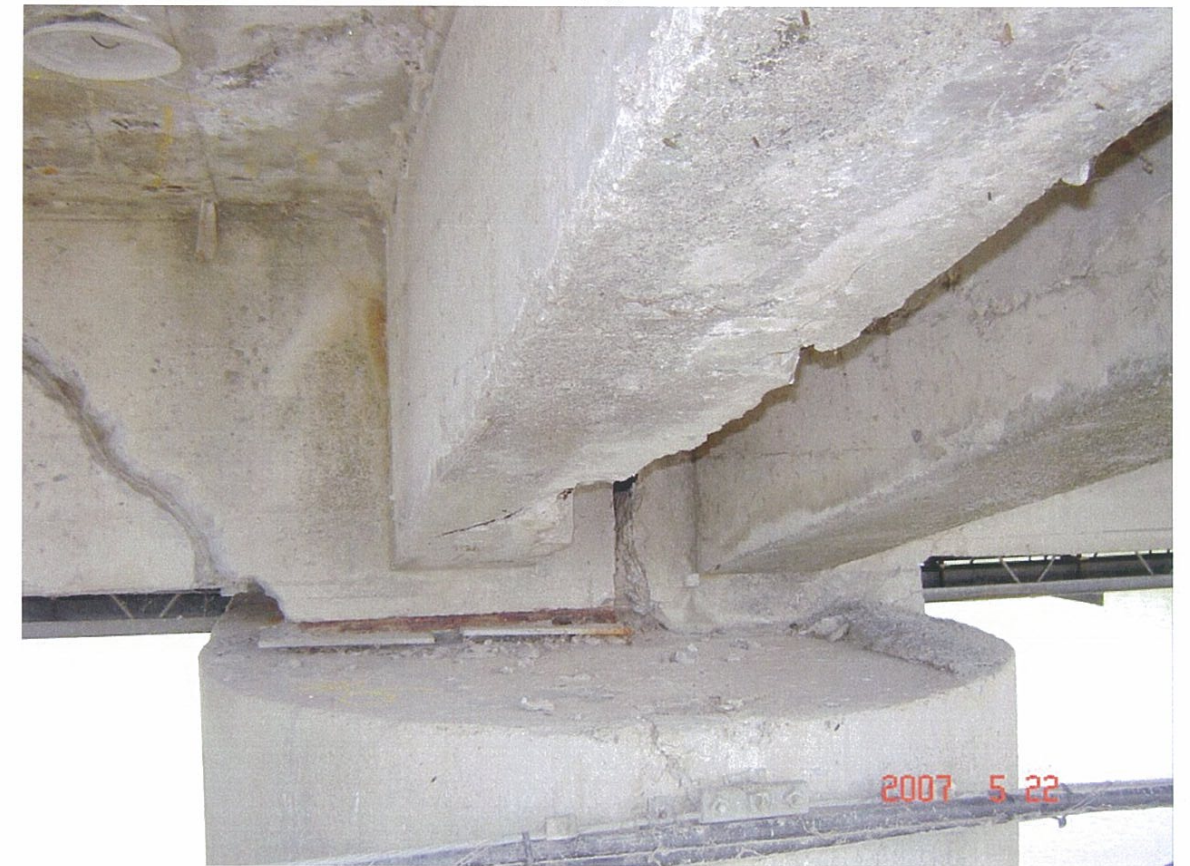
37 Typical bridge bearings, east Bearings on Pier 6 shown

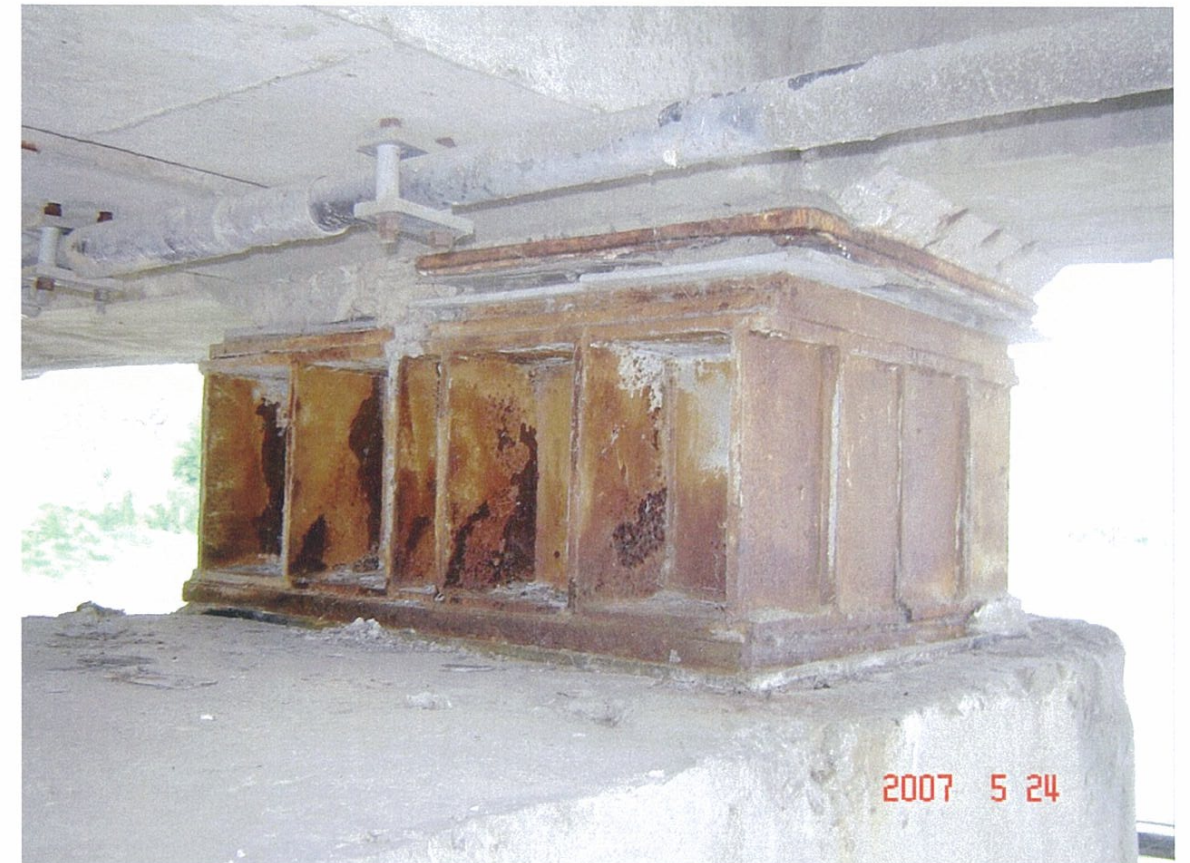
38 Steel pedestal for bearings at Pier 3 (TYP)

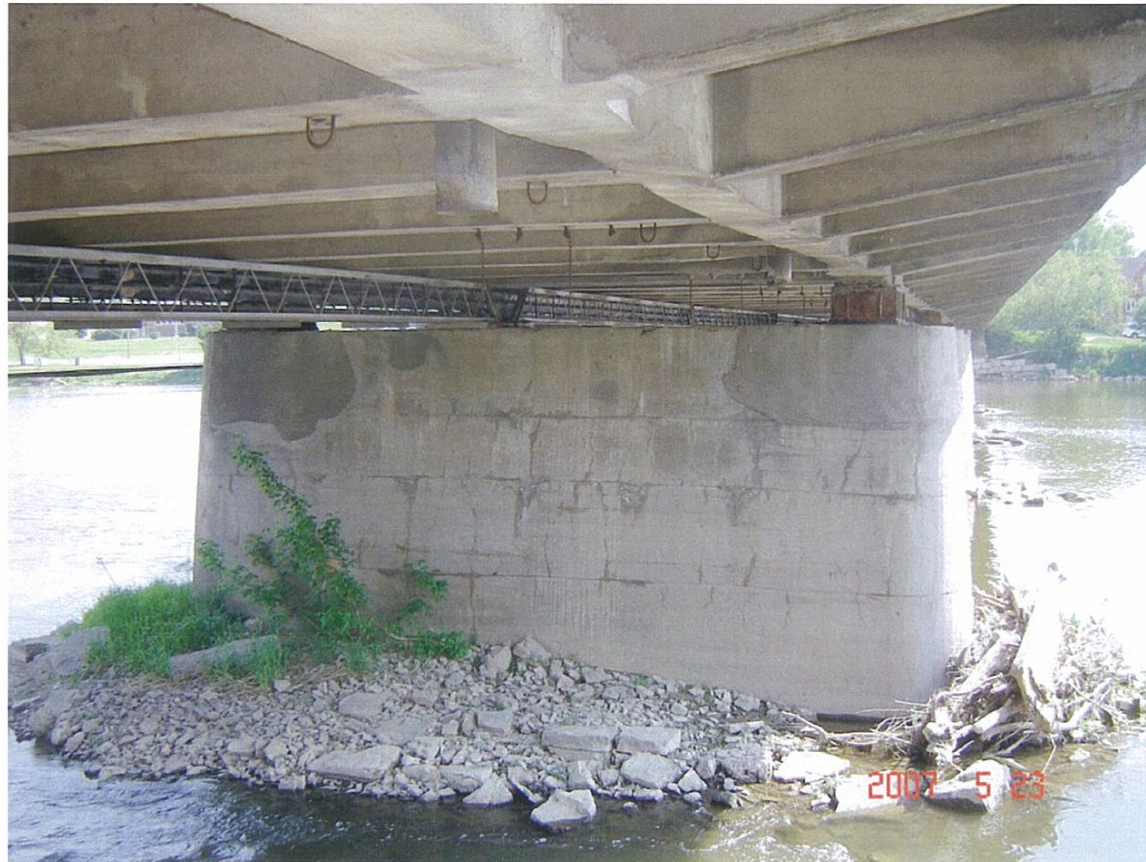
39 Typical pier profile , north elevation of Pier 3 shown

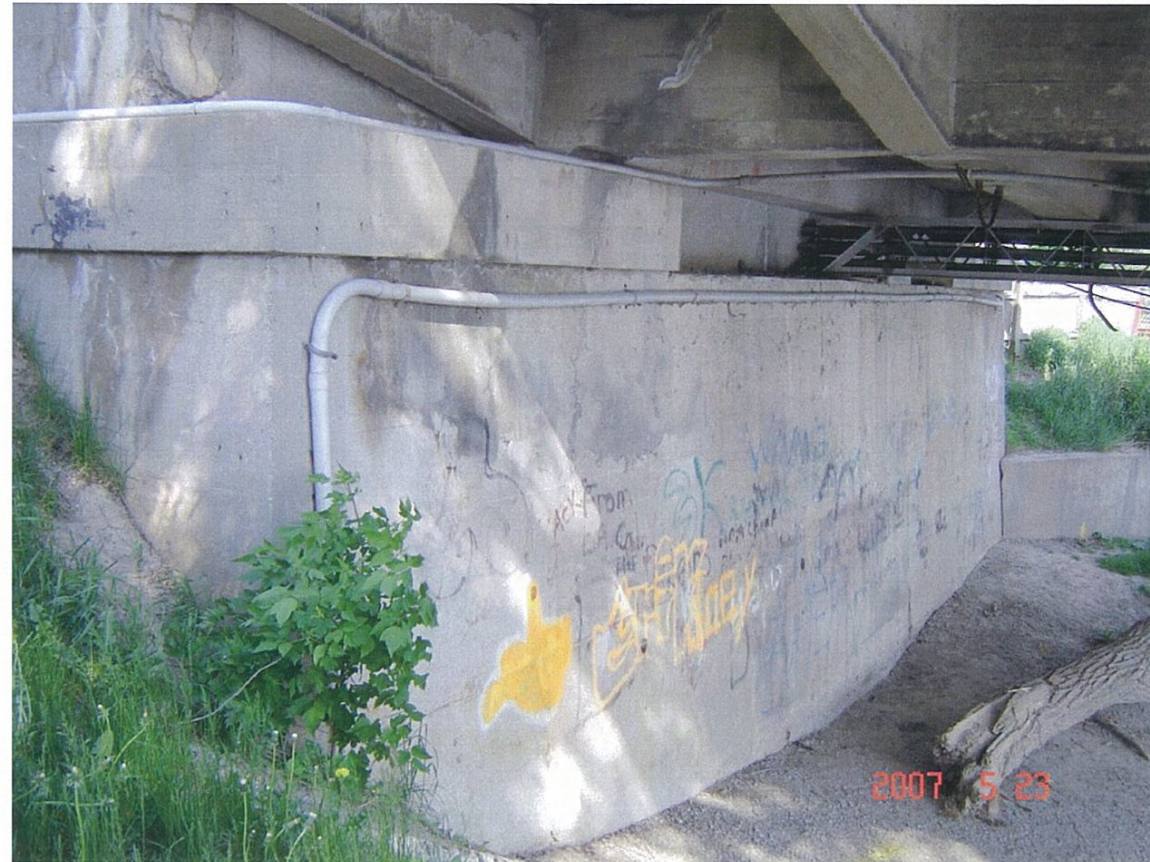
43 North Abutment

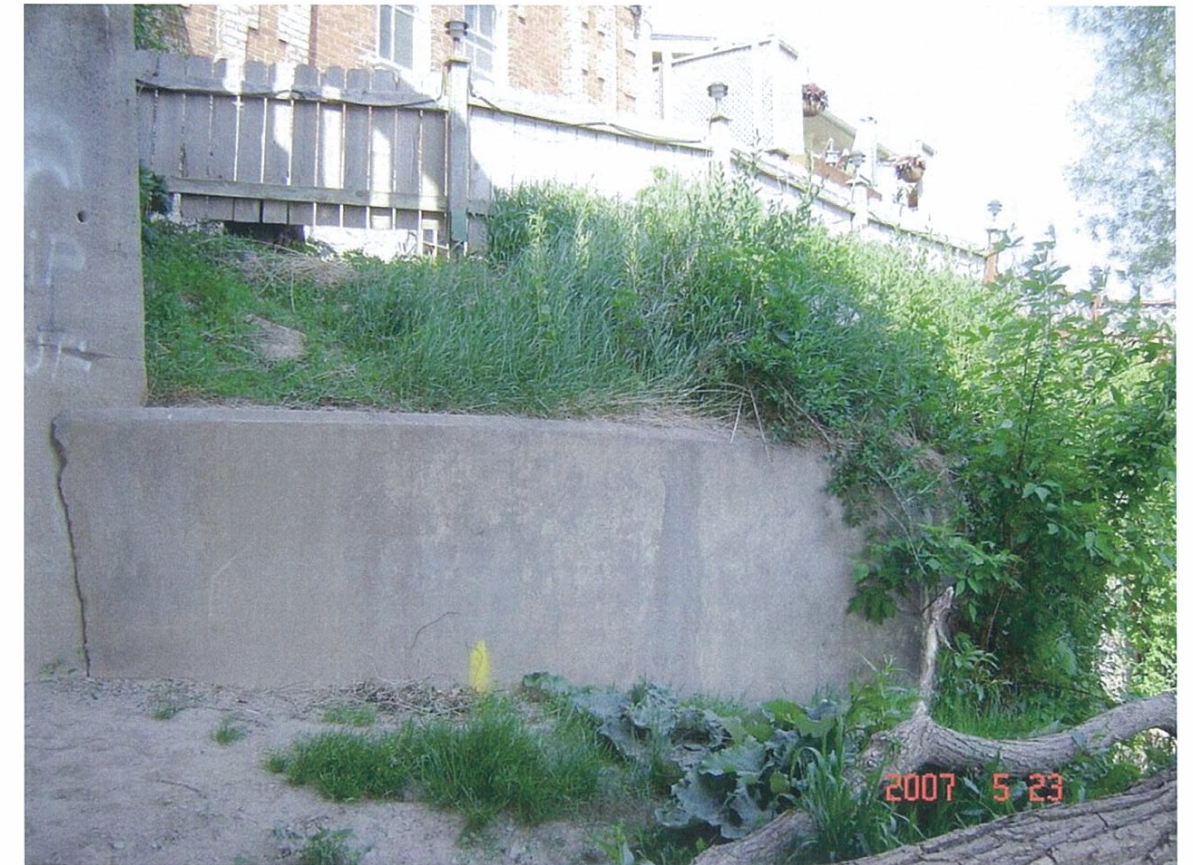
46 NE Retaining Wall

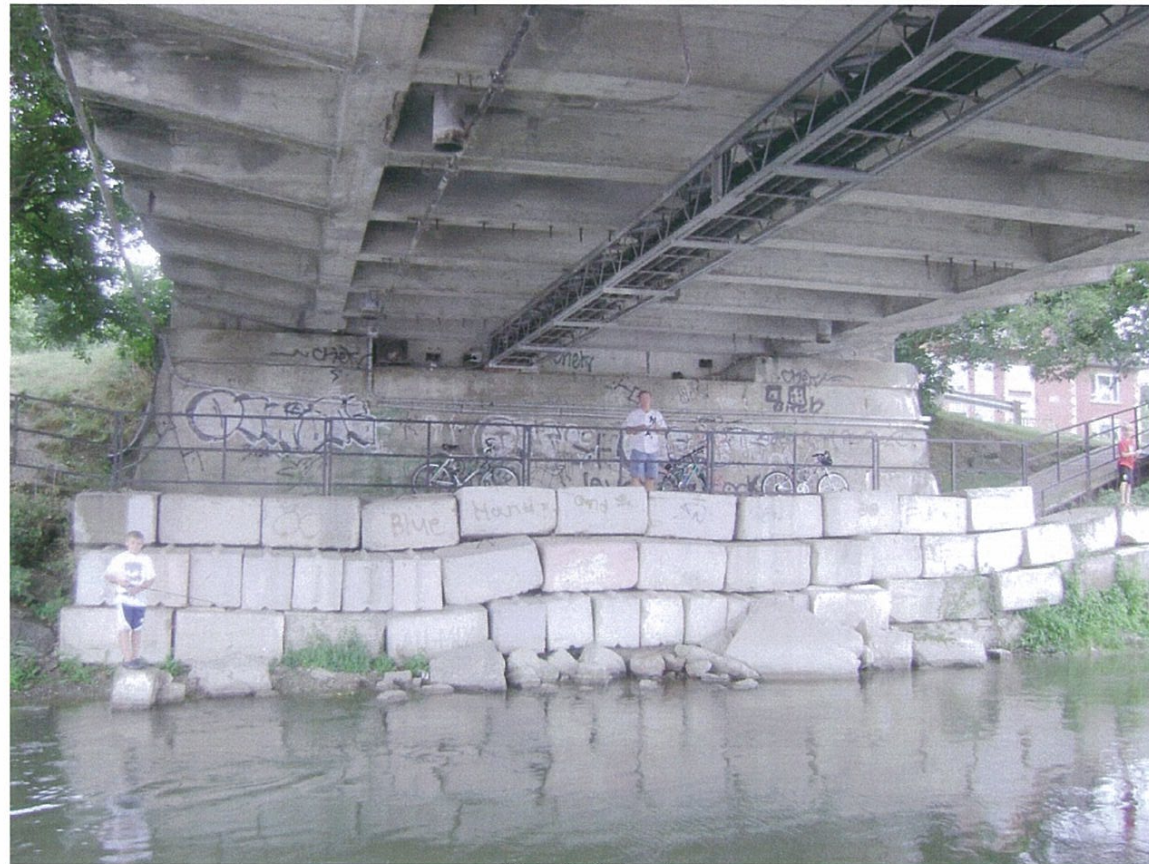
47 South Abutment

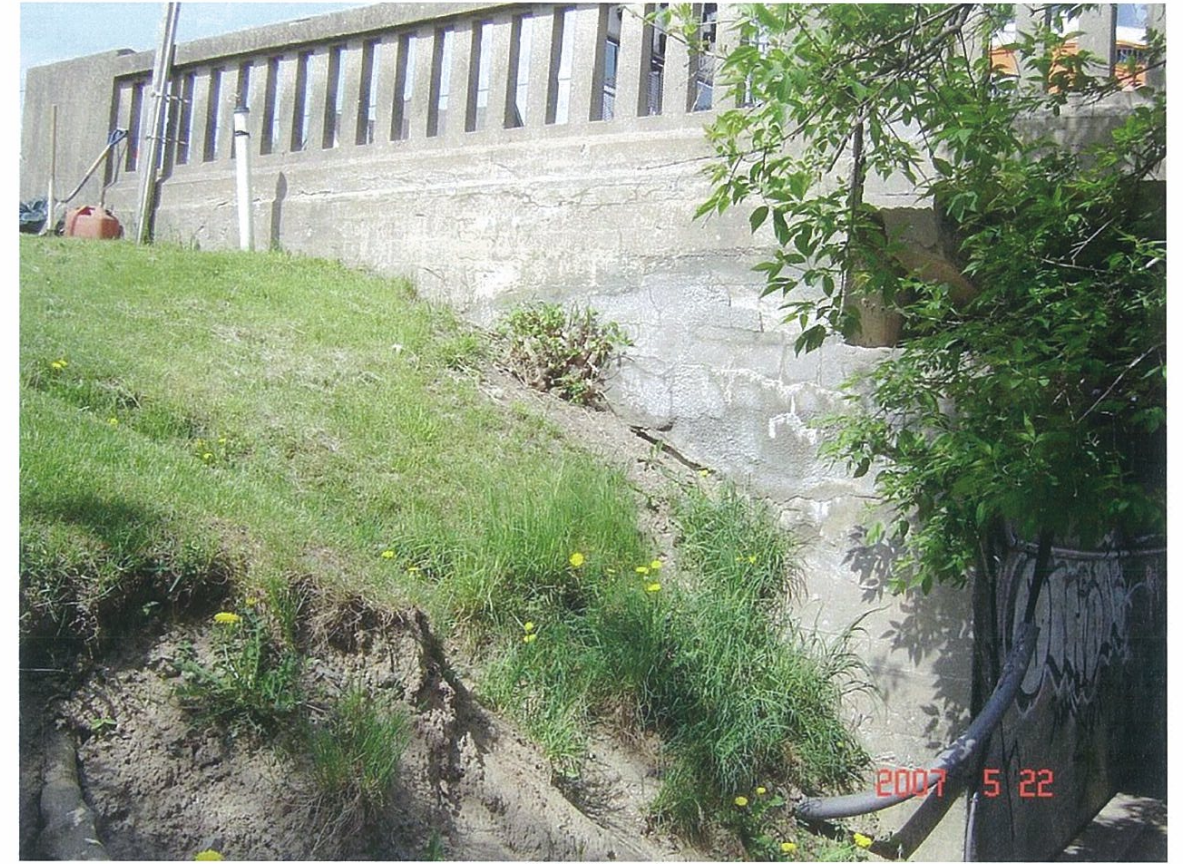
49 SE Wingwall

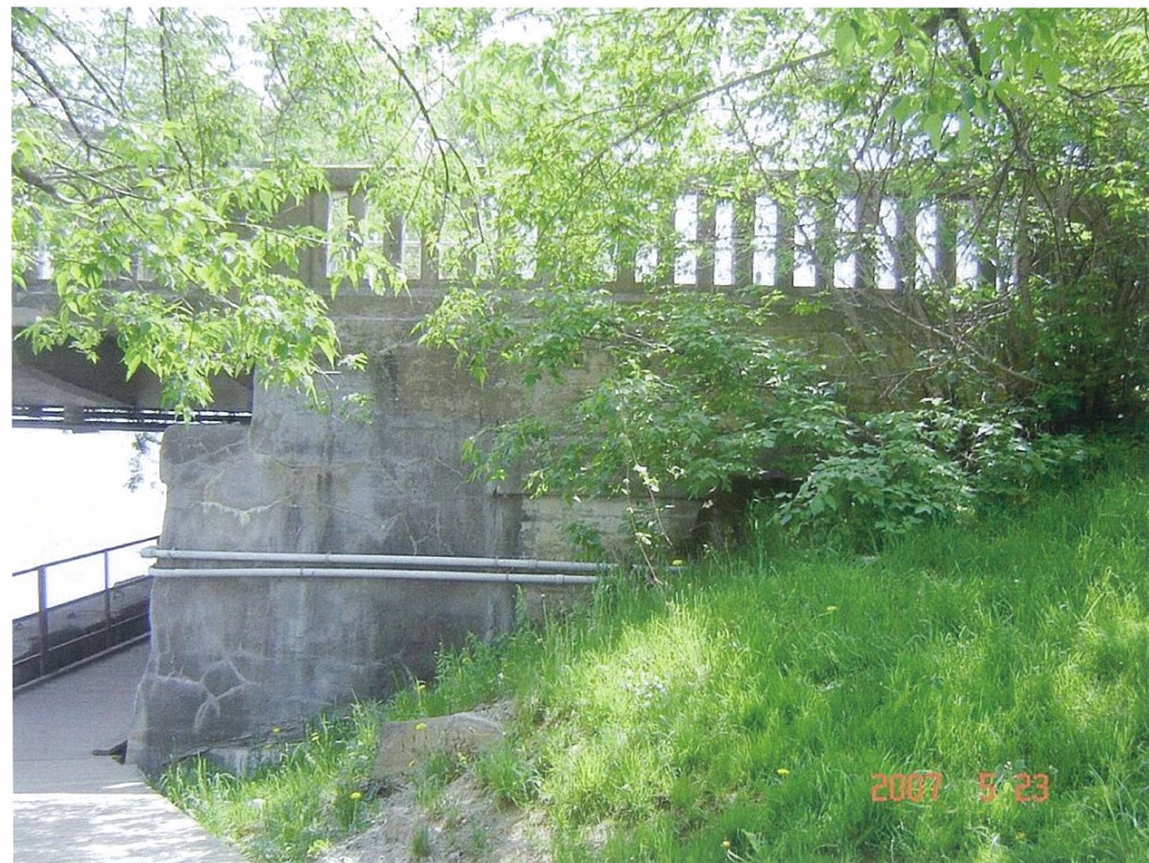
48 SW Wingwall

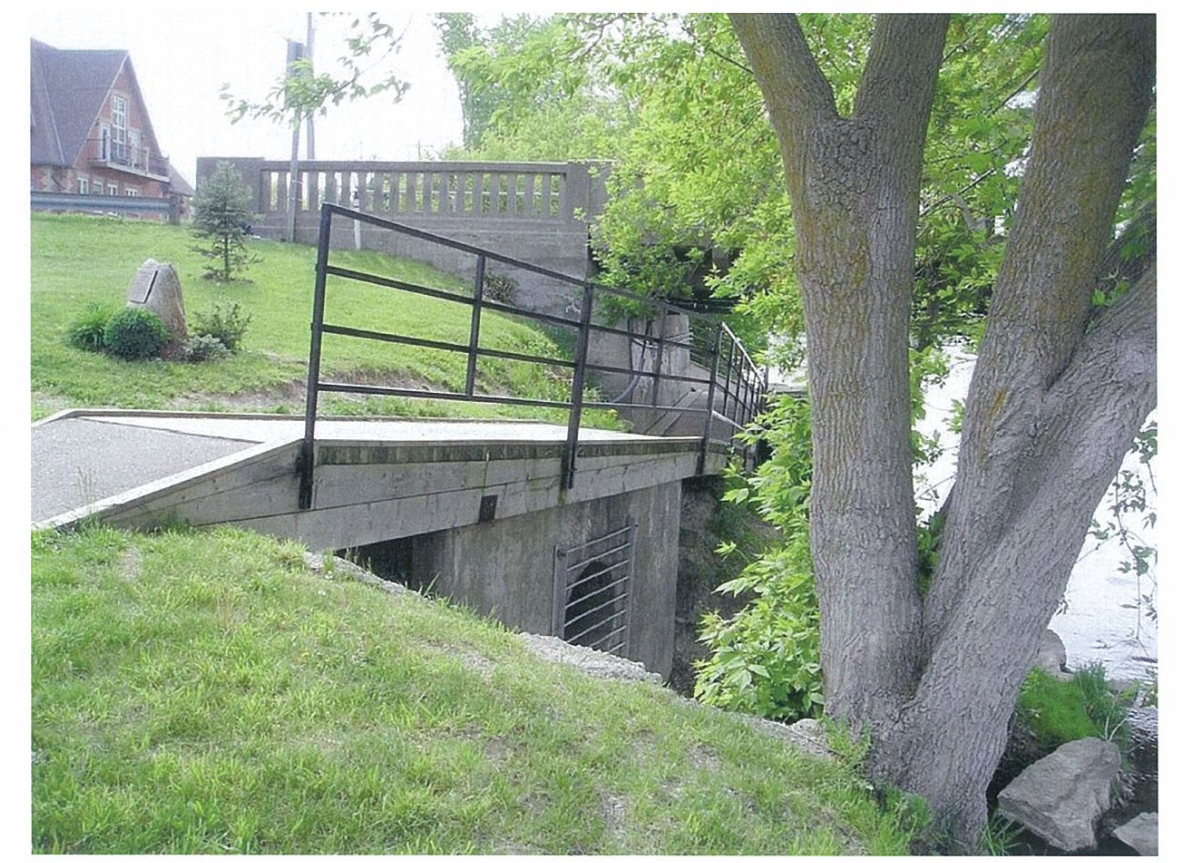
50 Boardwalk @ South Embankment
